1628 Restoration potential of old dams in Norway

A pilot study of occurrence, characteristics and restoration potential in watercourses with anadromous and resident fish stocks

Eloranta, A., Thomassen, G., Bergan, M.A., Andersen, O. & Gregersen, F. 2019. Restoration potential of old dams in Norway. A pilot study of occurrence, characteristics and restoration potential in watercourses with anadromous and resident fish stocks. NINA Report 1628. Norwegian Institute for Nature Research.

Trondheim, February 2019

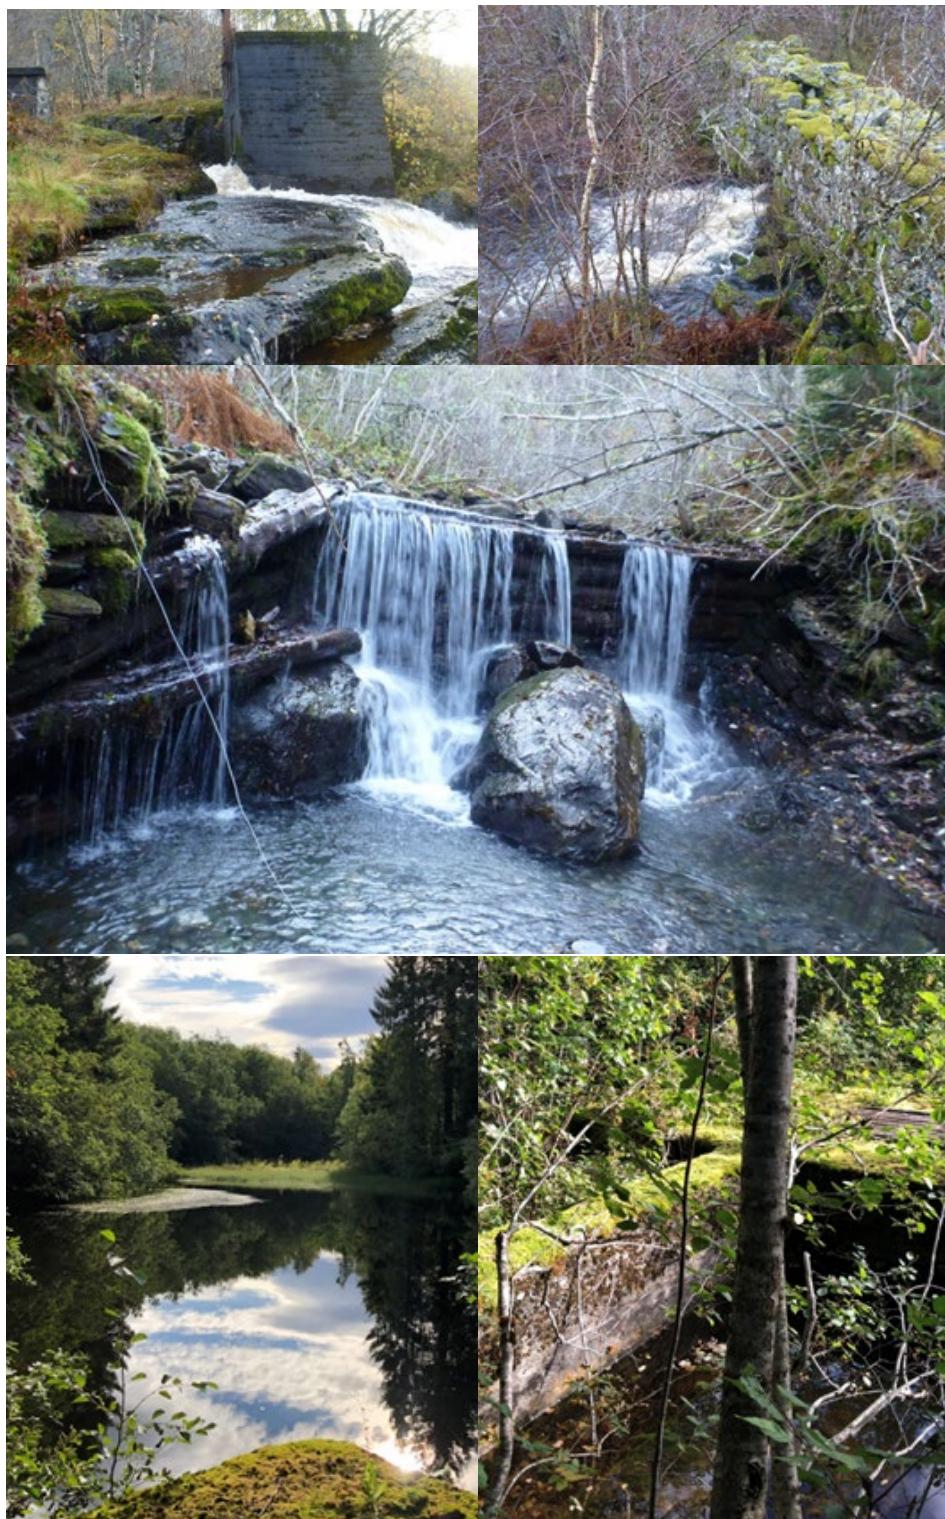
Figure 5. Remains of old dams in Fosen area (top row), in a tributary to Orkla (middle), and Hofstadelva, a tributary of Gråelva in Stjørdalsvassdraget (bottom row). See Bergan (2014b), Bergan & Steen (2013) and Bergan et al. (2017) for more details of these streams with anadromous fish populations, respectively. Photo: © Morten Andre Bergan.

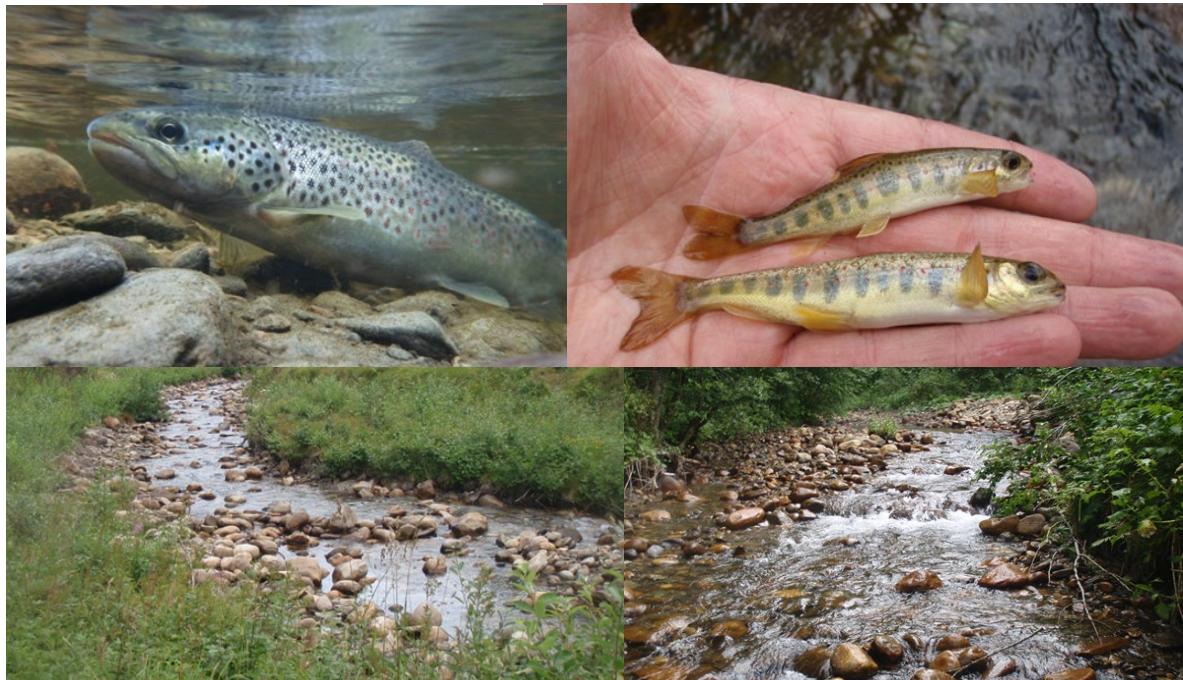
Based on estimates by Bergan & Solem (2018), over 50 % of the total length and area of potential spawning and nursing habitats for anadromous fish are lost due to the three mentioned dams in Kaldvella. Removing these barriers or building fish ways would allow migratory fish to utilize upstream areas offering better water and habitat quality than found downstream of the fish hatchery (**Figure 6**; Bergan & Solem 2018).

Figure 6. Adult sea trout and juvenile salmon caught downstream of the dams in Kaldvella on 23rd September 2013 (top row). Upstream stretches of Kaldvella with little human activity and good but inaccessible habitat for anadromous fish. Photo: © Morten Andre Bergan.

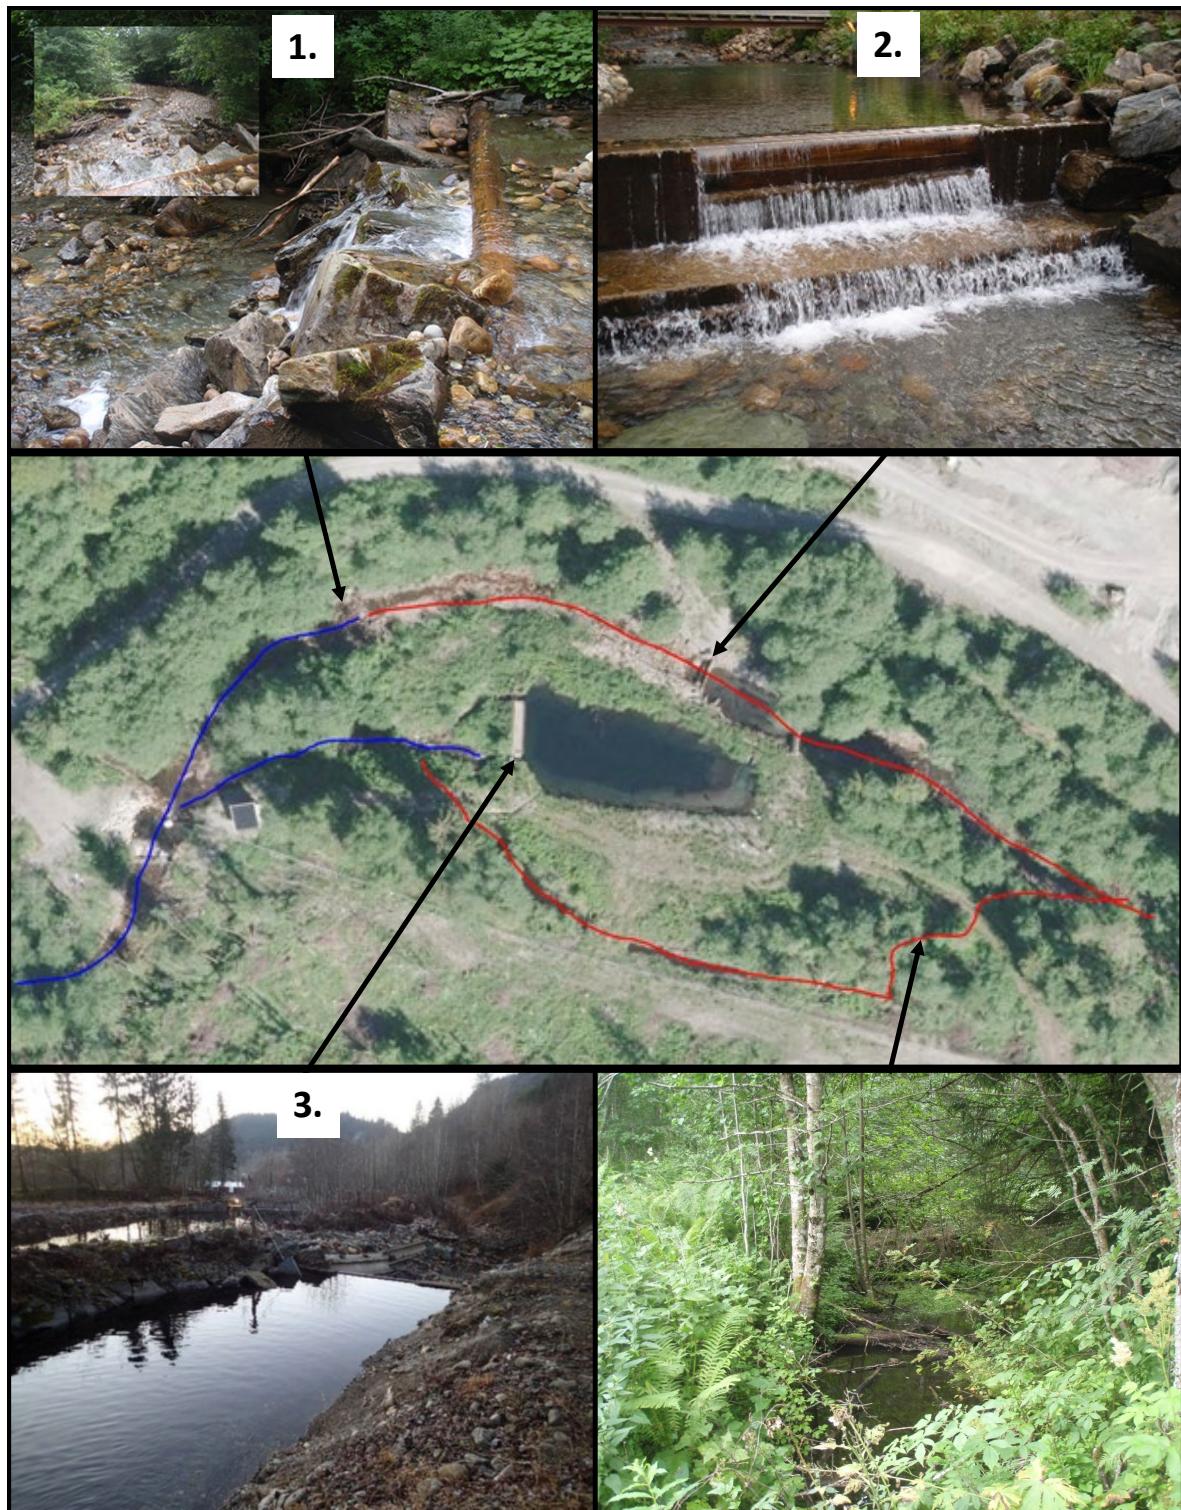
Dams built for fish hatcheries also affect anadromous fish populations in Kaldvella, a tributary to Gaula river in the municipality of Melhus (**Figure 4 and 6**). Kaldvella used to be an important spawning habitat for salmon and sea trout. Today, three dams prevent access of migratory fish to upstream spawning habitats (**Figure 6 and 7**). Adult and juvenile salmon and sea trout have been observed all the way up to a 1.5–2 m high and approx. 8 m wide dam made of large rocks and gravel (**Figure 7**; Solem et al. 2014). The purpose of this relatively old dam (#1) is unknown, but it may have been built for agriculture or to obtain water for the A/S Lundamo Settefisk fish hatchery. Later, a 1–1.5 m high and ca. 5 m wide concrete dam (#2) and a reservoir with an approx. 8 m wide dam (#3) were built in separate branches of the Kaldvella stream (**Figure 7**). It is unknown whether these dams are or will be used, depending on the plans of Lundamo Settefisk hatchery.

Figure 7. Location and photos of three dams in Kaldvella. The dams prevent access of anadromous fish to upstream spawning and nursing areas (inaccessible stretch shown with a red line) and cause partial drying of a side branch of Kaldvella (see photo in lower right corner). Photo: © Morten Andre Bergan. Aerial photo obtained from <https://kart.finn.no>.

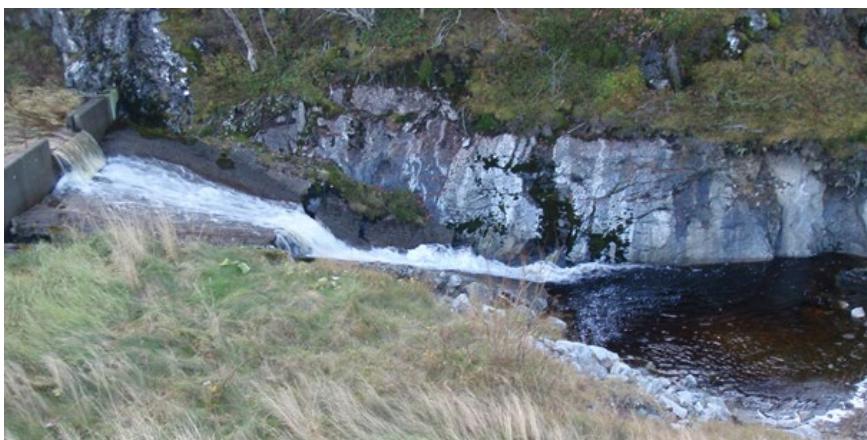
Based on electrofishing surveys, a scarce sea trout population still exists at the lowest stretch of the Dragvatnet outlet, whereas the upper, temporarily dry stream section is nearly fishless (Størset 2011; Bergan 2012a). Bergan (2012a) estimated that 79.5% (i.e. 862 m of a total 1085 m) of the potential stream stretch for anadromous fish in the Dragvatnet watercourse is currently lost due to the concrete dam at the lake outlet. Bergan (2012) also estimated that the dam may have caused an annual loss of over 9000 smolts and up to 1000 spawning (1SW) sea trout. Hence, dam removal or a nature-like bypass channel seem to be promising mitigation measures to improve recruitment potential of anadromous and resident fish populations, as well as the ecological status of Dragvatnet and its connected streams. Overall, a comprehensive survey of migration barriers and restorations in small streams along the Norwegian coast is urgently needed to preserve genetically unique anadromous fish stocks utilizing these widely ignored but potentially very productive river networks.

Figure 8. A concrete dam with a downstream chute at the outlet of Dragvatnet. Photo: © Morten Andre Bergan.

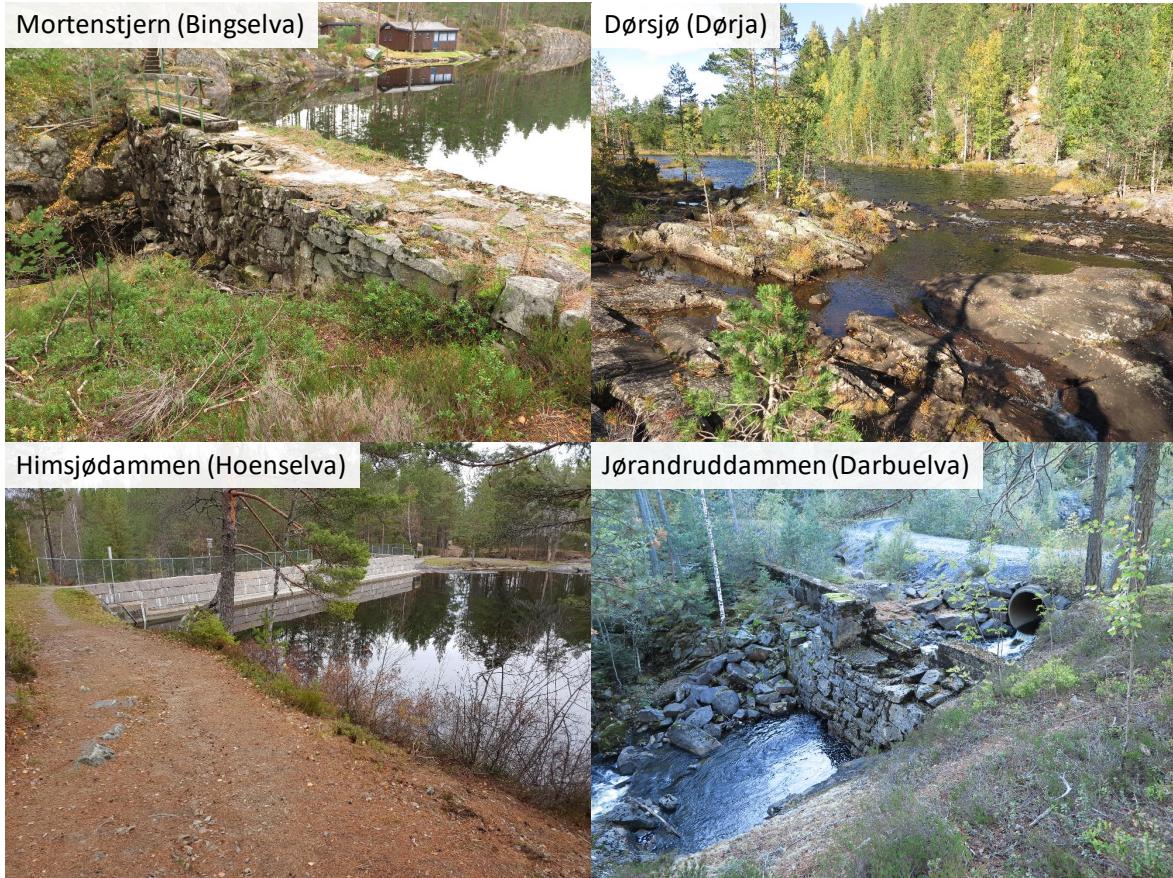
Figure 11. Photos of dam locations in different tributaries of Drammenselva. The old dam at the Dørsjø outlet in Dørja river is already removed. Photos: © Finn Gregersen.

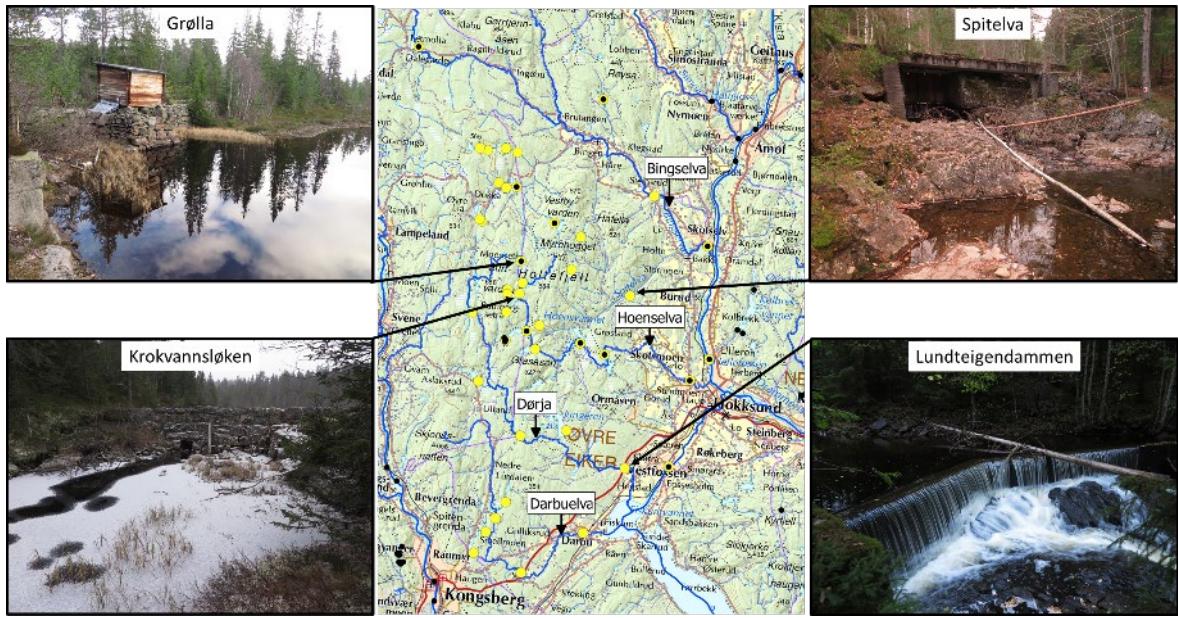
The reported and unknown dams in Drammenselva watercourse apparently decrease connectivity of the river network and reduce the access of migratory fish to suitable spawning, nursing and overwintering habitats (**Figure 10 and 12**). Many of the small streams in this area have good water quality and host populations of endangered freshwater pearl mussel which, in turn, are strongly dependant on salmonid fish (in this case brown trout) as hosts for their larval stages. Therefore, improving migration potential and living conditions for salmonid fish in tributaries of Drammenselva would support recruitment of the freshwater pearl mussel and the well-being of other invertebrate, plant and vertebrate species living in these unique ecosystems. However, in many cases, such mitigation measures are not straightforward and feasible due to e.g. relatively high costs and minor socio-economic benefits, as well as other ecological and societal values associated with the existing dam structures.

Figure 12. Potential targets for dam restorations in the study tributaries of Drammenselva in Øvre Eiker, southern Norway. Photos: © Finn Gregersen. See Appendix 4 for more detailed description.

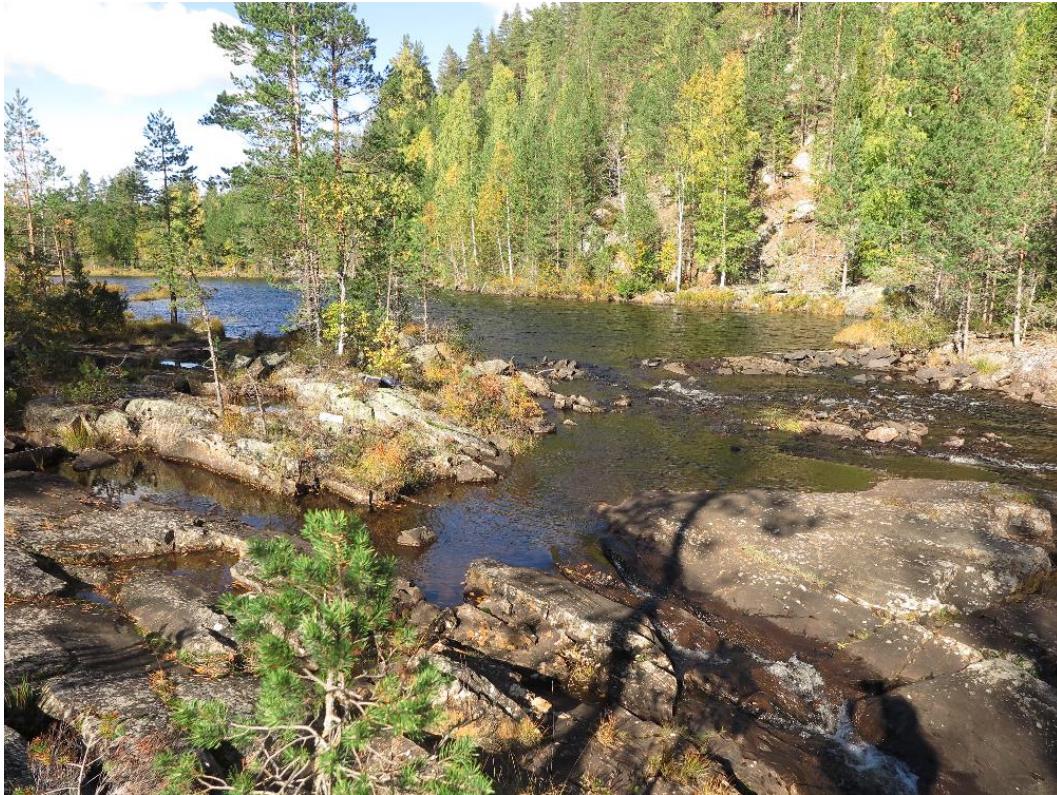
Figur 3: Tidligere damsted ved Dørsjø i Dørja.

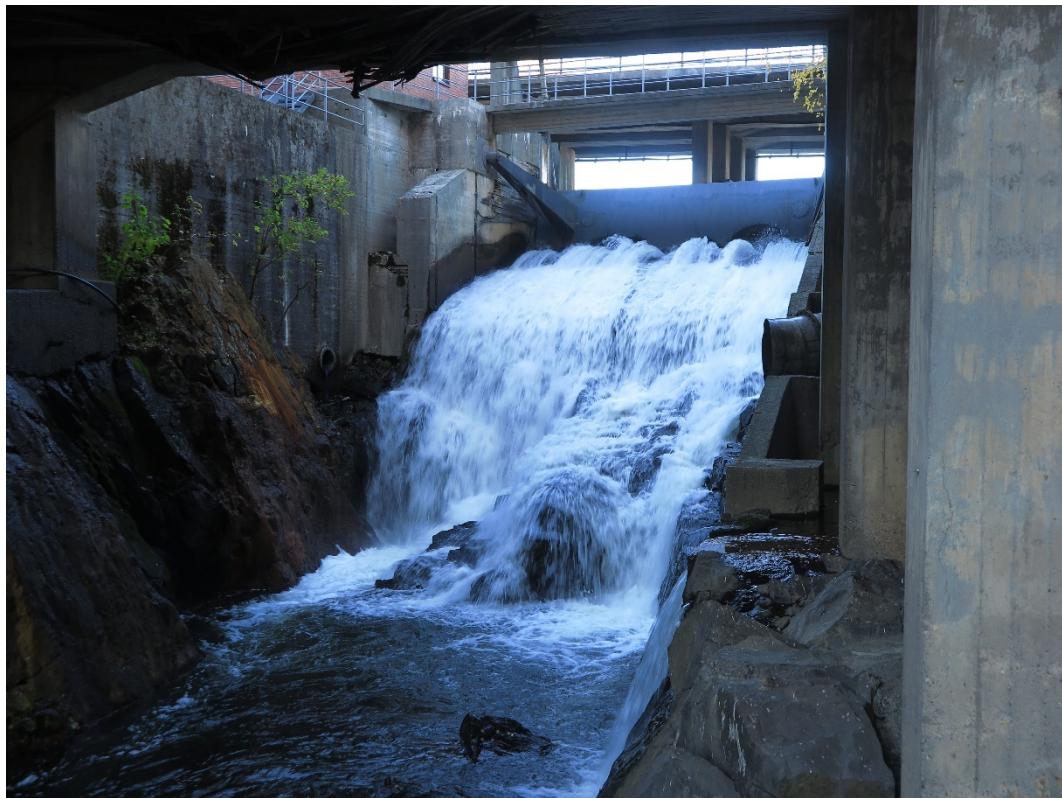
Før eventuell vandrende fisk kan komme opp i Darbuelva og Dørja må den gjennom Vestfossen og dammen som finnes der (Figur 8). Det byr på utfordringer. Her ligger det et kraftverk. Det er ingen fisketrapp ved kraftverket, men det er installert en ålerenne her.

Figur 8 Dammen i Vestfosselva.

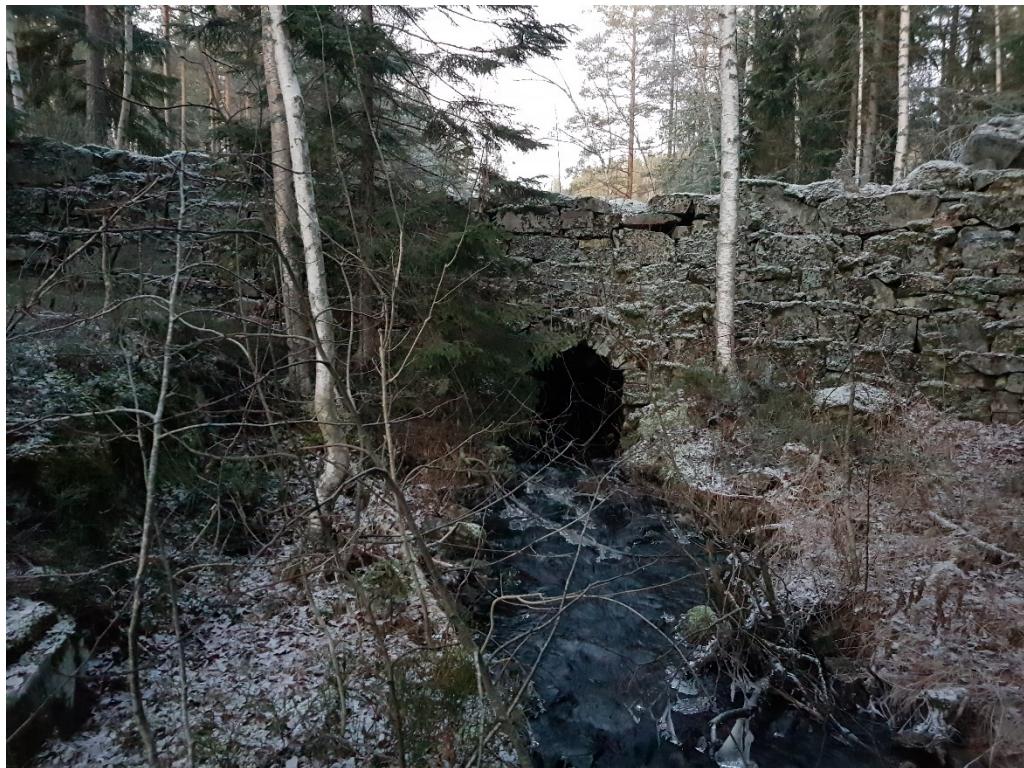
Her finnes en svært gammel steindam fra 1800-tallet (Figur 11). Magasinet har sunket et par meter grunnet lekkasje i dam. Fisk greier ikke å passere dam eller gå igjennom bunnluken fordi masser har kollapset sammen og tettet denne. Det tidligere så store Grønntjern er nå i søndre deler en stor myr/våtmark med bekk igjennom og den nordre delen utgjør et mindre tjern (Figur 12). Den naturlige restaureringen av systemet som følge av lekkasjen i dammen har gått meget fint.

Figur 11 Den gamle steindammen på Grønntjern.

Det er ikke lange fiskeføringer oppstrøms men det hadde vært gunstig om fisken i Grønntjern hadde kunnet passere damsted for å bruke de fine bekkestrekningene nedstrøms. Man bør åpne/renske bunnventil for å fremme fiskevandringer. Dammen er trolig uansett for dyr å restaurere og tette. Å rense bunnventilen i dammen er en billig operasjon som vil øke potensialet for fiskevandringer kraftig. Det at dammen uansett har gått lekk og vatnet sunket har gitt mye våtmark som er å regne for en miljøbonus.

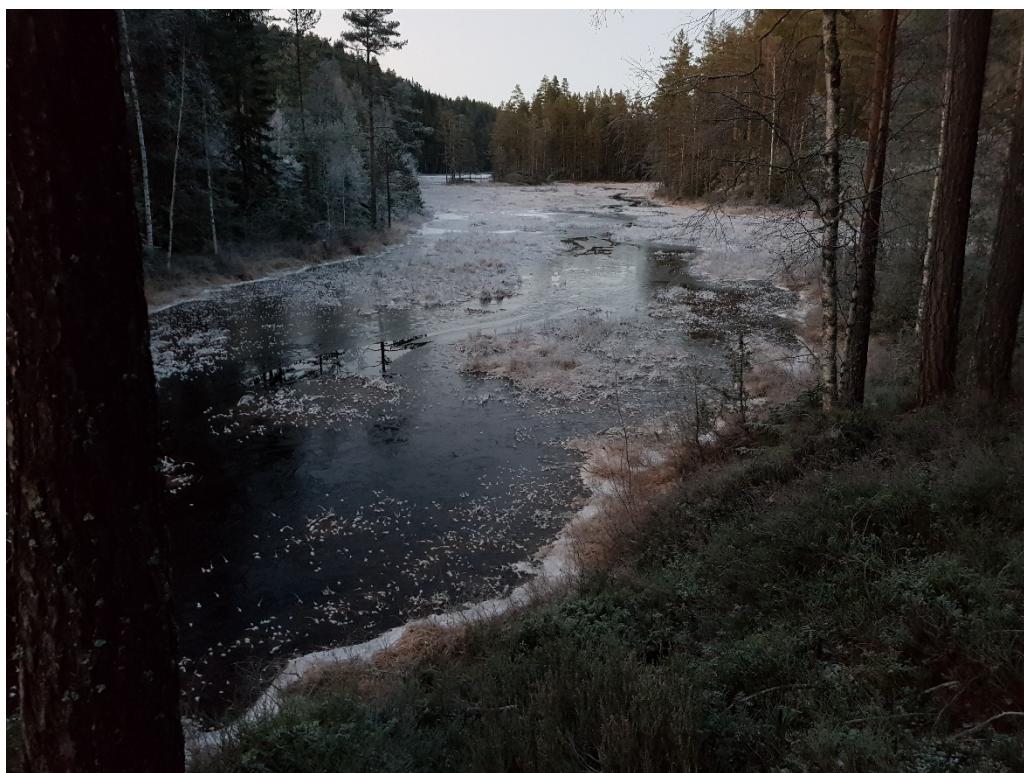
Figur 12 "Ny" våtmark i Grønntjern.

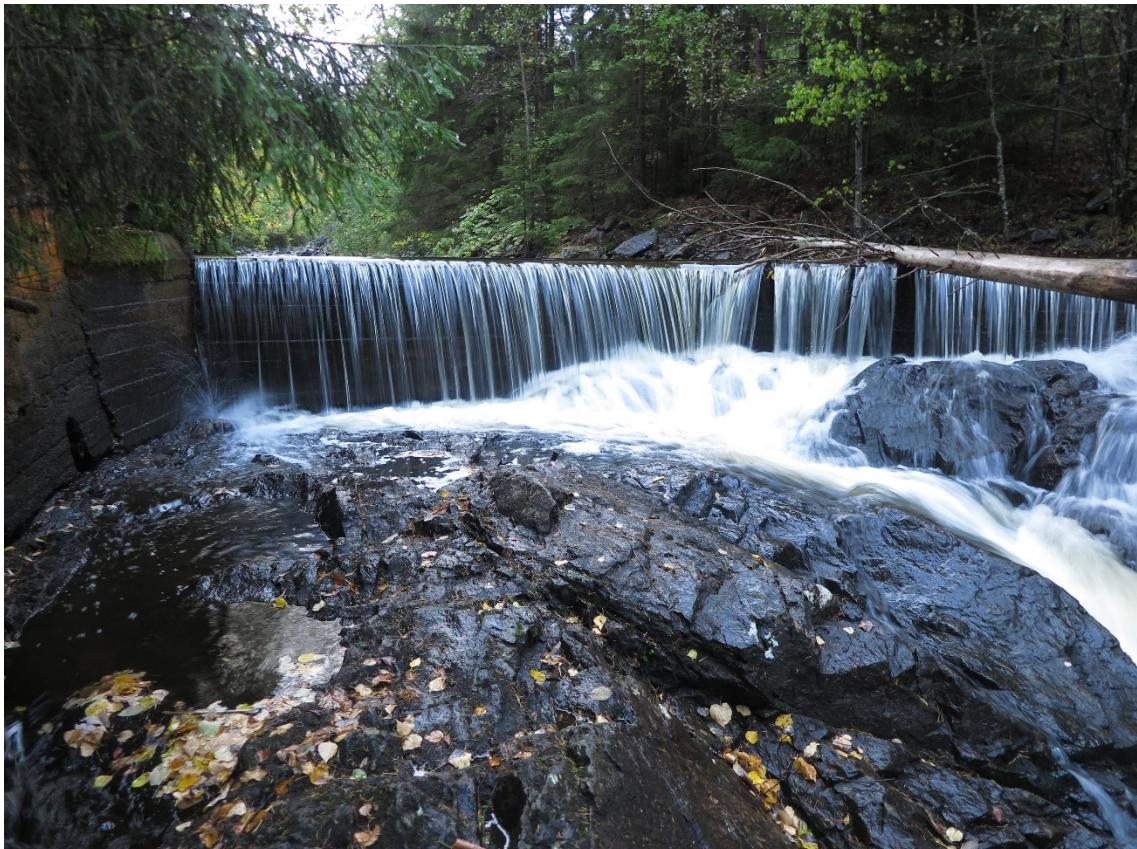
Figur 13 Lundteigendammen i nedre deler av Dørja.

Her vil det være en stor gevinst for musling og ørret dersom dette er et forsvarlig tiltak. Genetikk vil kunne avklare om det har vært historisk genflyt av storørret over disse barrierene. Dersom det er tilfelle vil en tilrettelegging for fiskevandring forbi denne dammen være et svært godt tiltak.

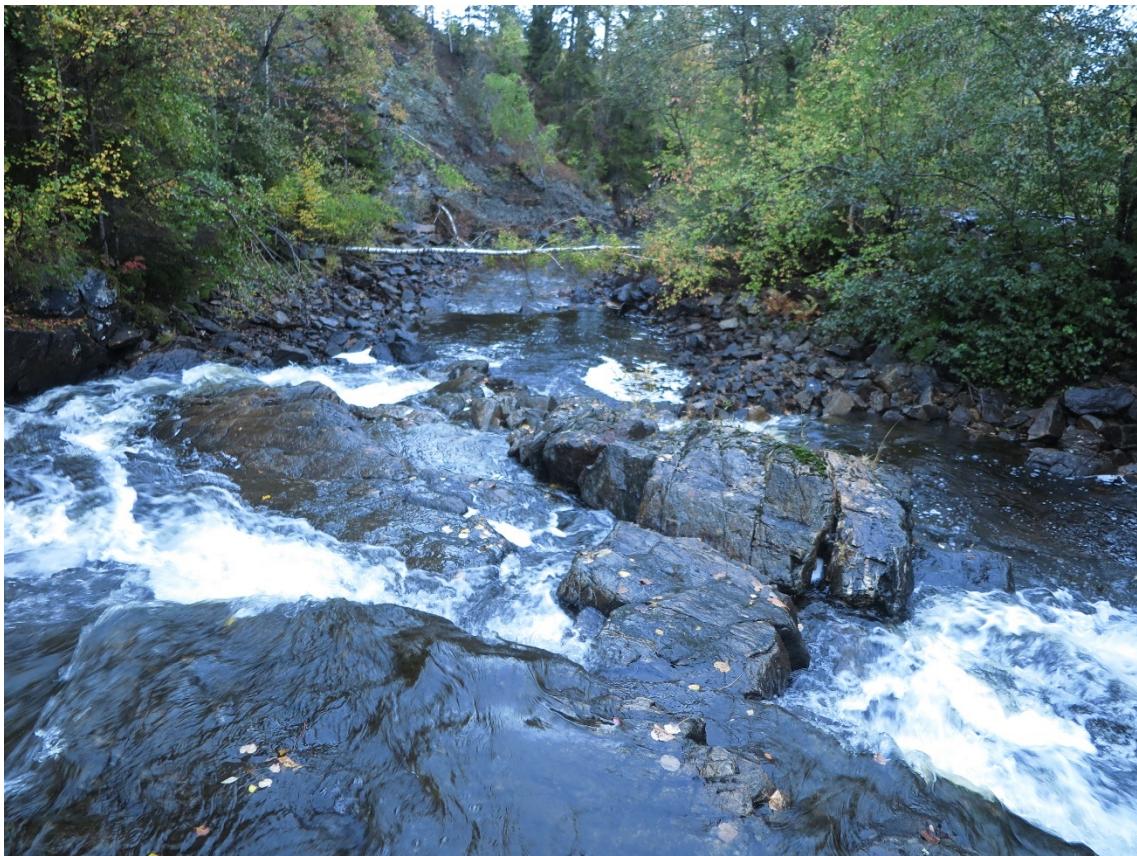
Figur 14 Fallene nedstrøms Lundteigendammen som kan være absolutte vandringshinder.

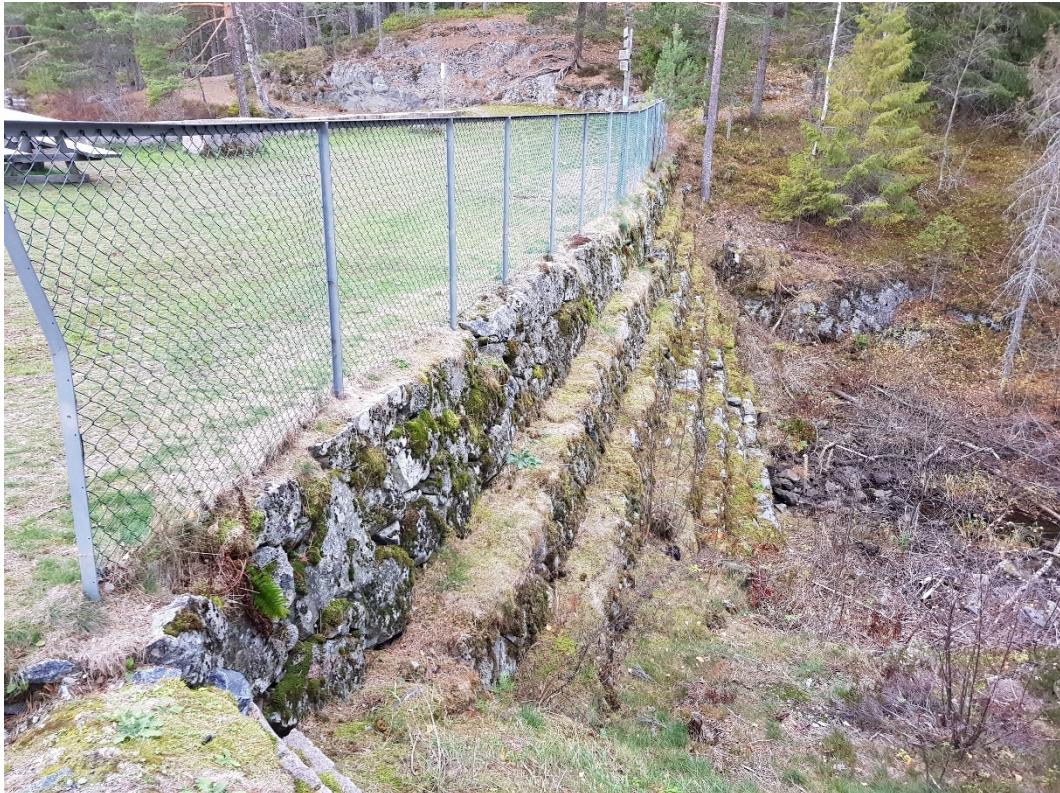
Figur 15 Nyrestaurert Himsjødam. Her er det ingen fiskepassasje.

Det er etablert en omløpsbekk forbi dammen på det overliggende Hoensvatnet. Dette gjør, at man ved et fungerende tiltak for fiskevandring her, ville gjenopprette konnektiviteten over en lang strekning i dette vassdraget.

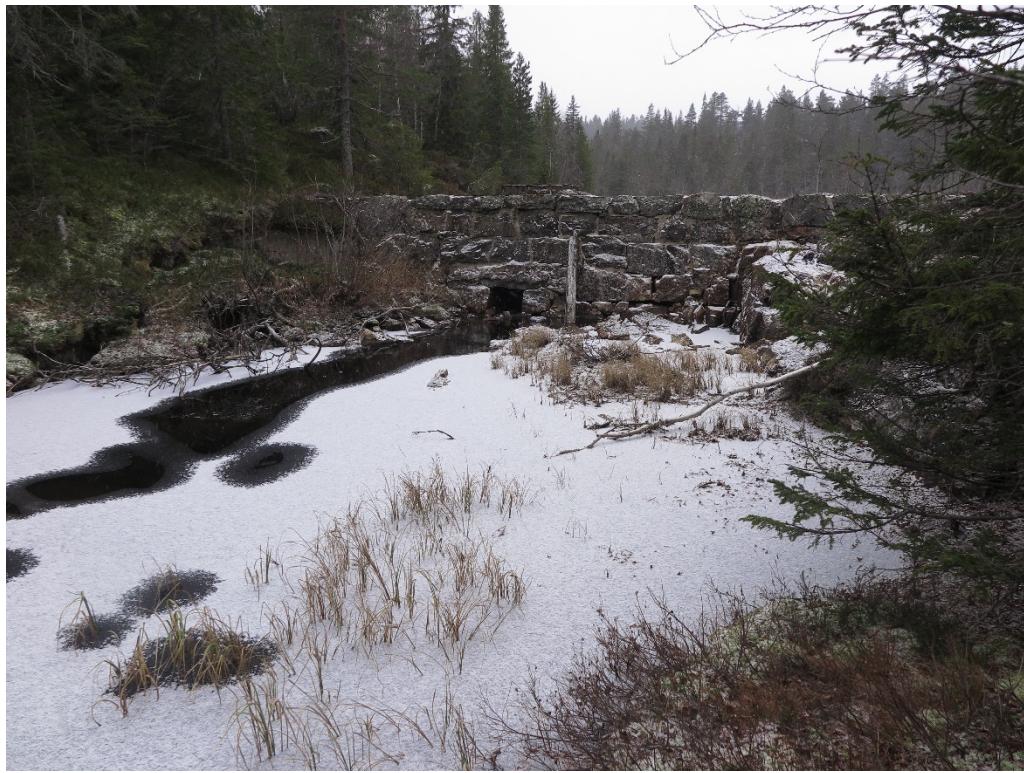
Disse to vannene ligger i de øvre deler av Hoenvassdraget. Krokvatnet er et av de store vannene i Holtefjell. Begge dammer er nylig flikket på og har antagelig en viss bevaringsverdi. I Krokvannsløken er dammen nylig sprunget lekk (Figur 16). Her har dammen en bunntappesluse som er helt lekk, men som allikevel hindrer fiskevandring. Ved Krokvatnet er det en omløpsbekk som bør tilrettelegges for å sikre fiskevandringer.

Figur 16 Dammen på Krokvassløken.

Realiserer man tiltak som gjenopprettet fiskevandringer ved begge disse dammene vil man sørge for å tilgjengeliggjøre store oppvekst-, leve- og gyteområder for fisken i den øvre delen av dette vassdraget.

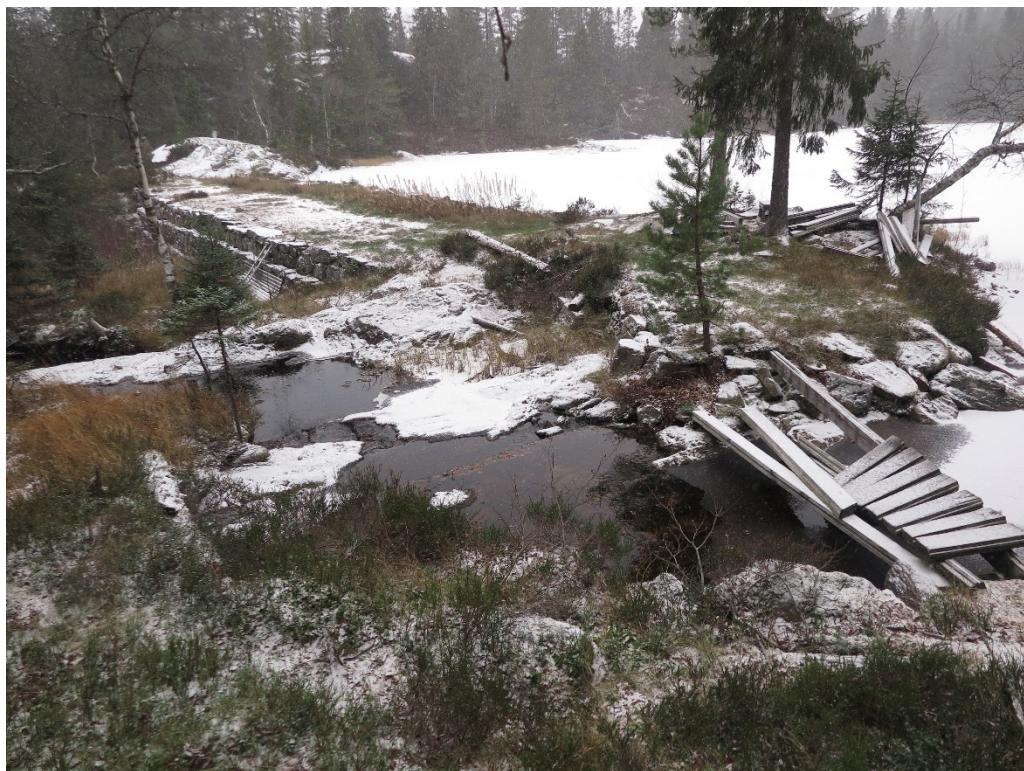
Figur 17 Dammen på Krokvann med overløpet nærmest fotograf.

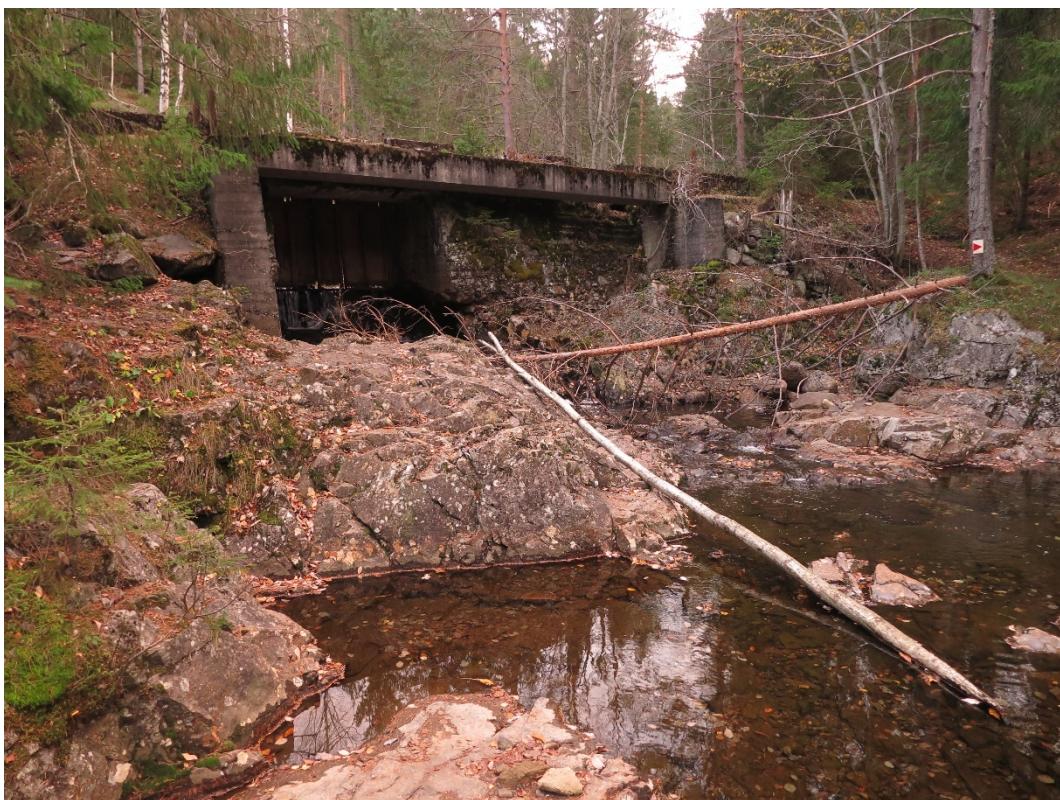
Figur 18 Dammen i Spitelva.

Det bør være enkelt å eliminere dette vandringshinderet. Dammen har, så vidt vi kan forstå, ingen funksjon og bruva over elva kan beholdes. Utbedres dette hinderet vil resultatet bli en god sammenbinding av bekkeørretbestander.

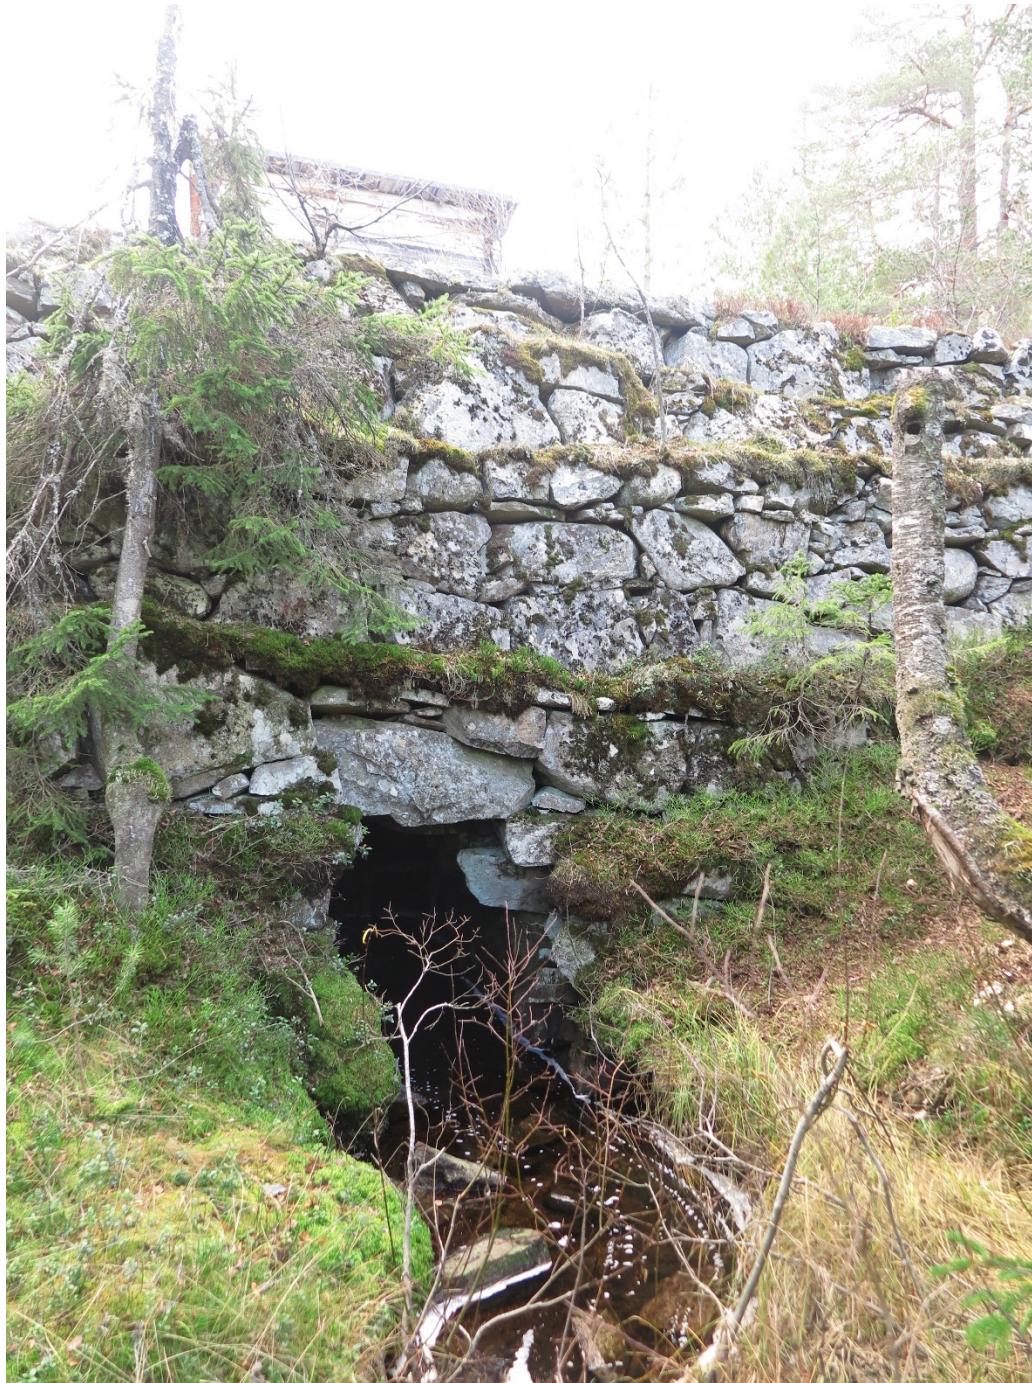
Grølla ligger høyt oppe i et fint vassdrag med fine gammelskogsomgivelser. Vannet er et næringsfattig vann som ligger sentralt på Holtefjell. Dammen (Figur 19) hindrer fisk fra å vandre både opp og ned. Dammen er antagelig bevaringsverdig som kulturminne, men den er ingen enkel sak å restaurere. Dammen lekker og deler av dammen, over lukehuset er sammenrast og som et resultat har vannet sunket betydelig. Det sees en markant reguleringssone på 0,5 meter som tyder på at lekkasjen har kommet nylig. Det er mulig at årets tørkesommer har bidratt til redusert magasinfylling.

Figur 19 Dammen på Grølla. Legg merke til tappehuset oppå dammen.

vandringsløsning forbi dammen for å tilgjengeliggjøre mer areal for fisken her. Om dammen ikke restaureres vil den ramle sammen og det kan da opprettes fiskepassasje ved enkle midler.

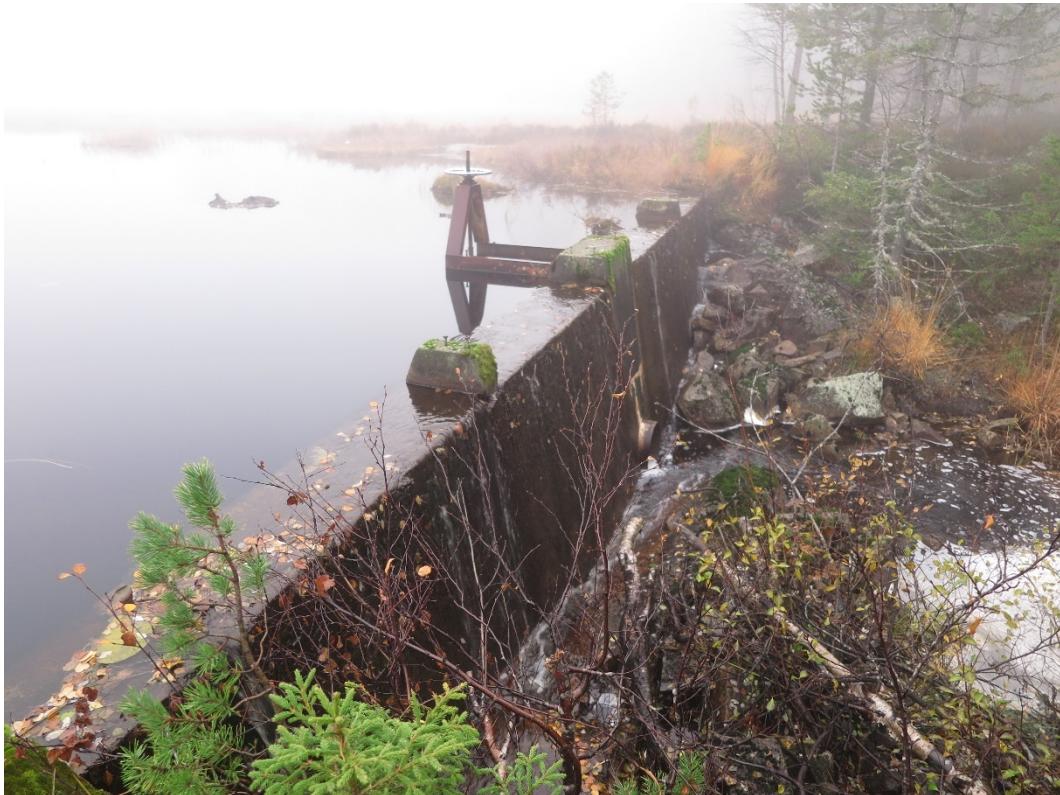
Dammen (Figur 20) er vandringshinder, og fjerning av dam eller å åpne tappesluse vil gi fisk tilgang til større gyte og oppvekstområder, men slike tiltak vil også få andre konsekvenser. Vannets størrelse vil synke dramatisk og mye myr og våtmark vil tørke inn. Dette er å anse som negativt for både hyttefolk og vannfugl i området. Det er imidlertid potensiale for å beholde dam og bygge en omlopsbekk på nordsiden av dam her. I dette tilfellet vil det kunne gi en løsning som ivaretar de fleste hensyn på en god måte.

Figur 20 Dammen på Høltjern.
