2387

NINA Report

Evaluation of fish trap and guiding fence efficiency in the River Tana in 2023

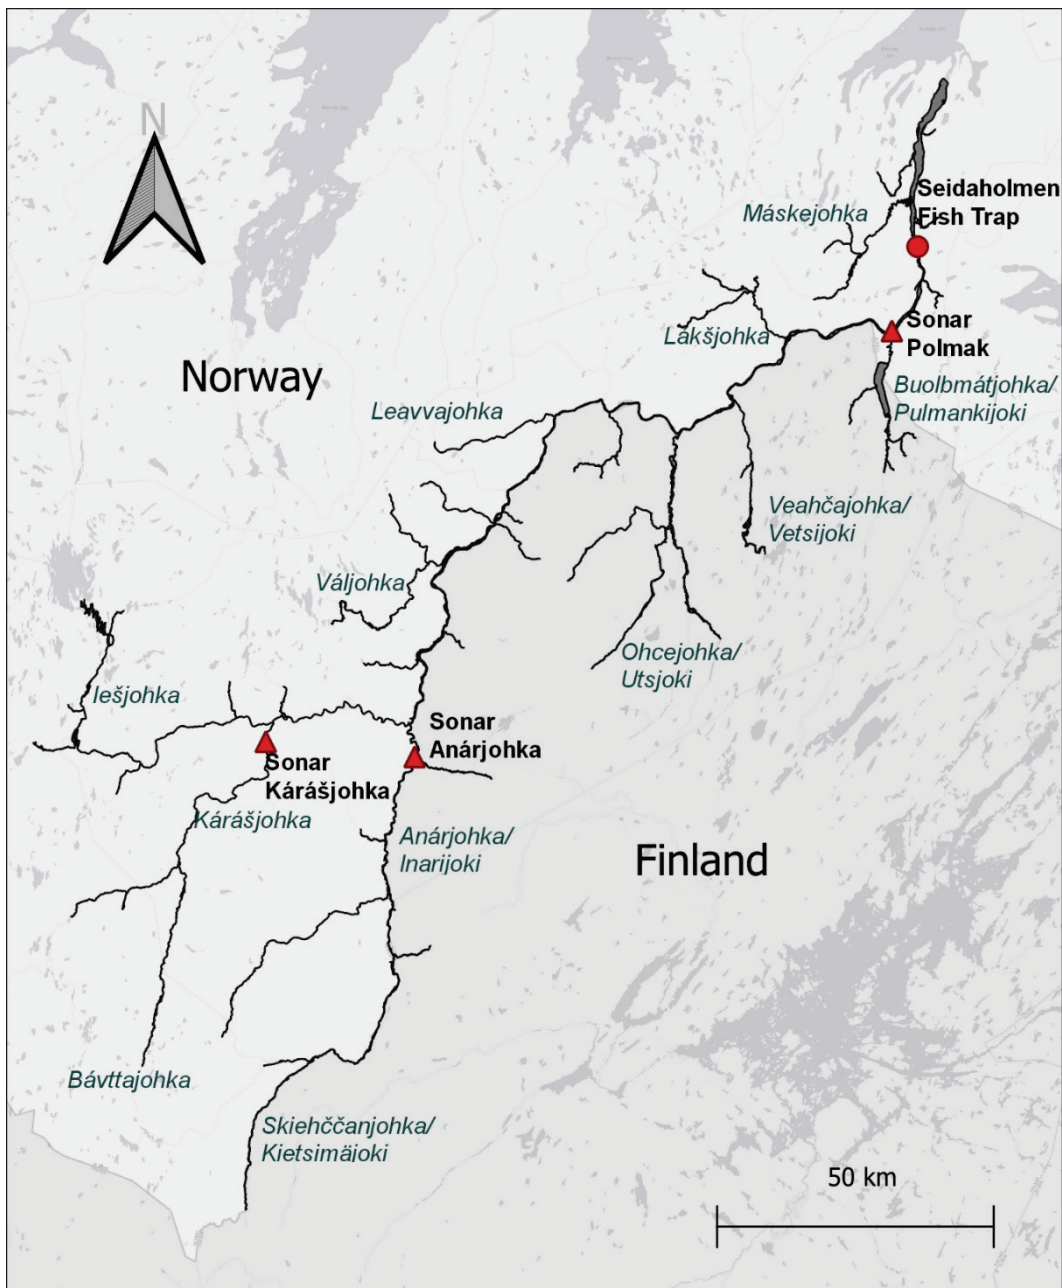
Figure 1. Estimated adult salmon distribution area in the Tana/Teno watercourse with the largest tributaries named. The Tana/Teno starts where Kárášjohka meets Anárjohka and drains in the Tana fjord in the north, making up 211 km of the total available river stretch of about 1 200 km. The filled circle marks the location of the fish trap during the summer of 2023. The filled triangles

mark the location of sonar monitoring stations. The Polmak location monitors the Tana/Teno main stem.

The Tana/Teno river (Norwegian/Finnish) is a Norwegian-Finnish watercourse, partially forming the border between the two countries, with a watershed area of 16 377 km². The mean annual discharge at the lower reaches (Polmak nye (234.18.0) measuring station; sildre.nve.no) of the river is approx. 197 m³s⁻¹. The Tana system is one of the most important Atlantic salmon (*Salmo salar*) rivers in the world and has about 1 200 km of river available for salmon, 211 km in the Tana mainstem and approx. 1 000 km in larger and smaller tributaries throughout the watershed (Figure 1).

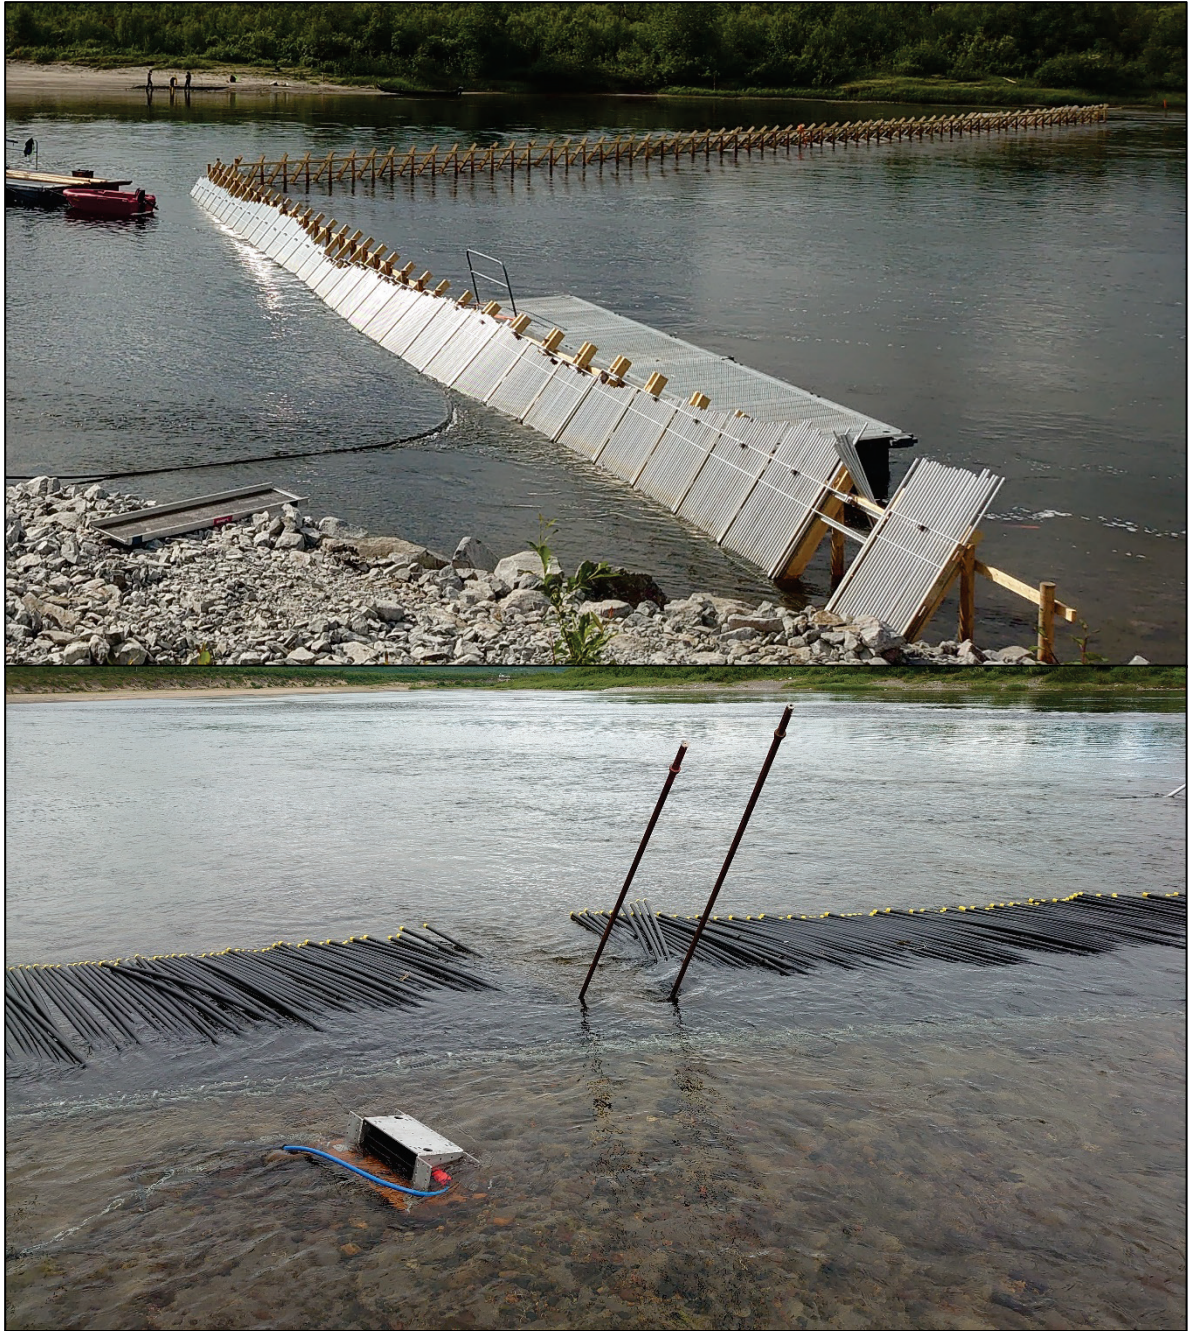
Figure 4. The eastern channel trap-fence system. The eastern channel trap-fence system consisted of a solid wooden structure supporting aluminium frames with aluminium tubes (top picture) and a short section (approx. 20 m) of flexible fence (bottom picture) on the western side of the fence. The bottom picture also shows the initial downstream migration solution in the eastern channel that was closed on the 30th of June, whilst the top picture shows the second downstream migration solution which was opened at different times throughout the trap operation period. Top photo was taken June 27th, 2023, and the bottom picture June 29th, 2023. Photos: S. Domaas, NINA.

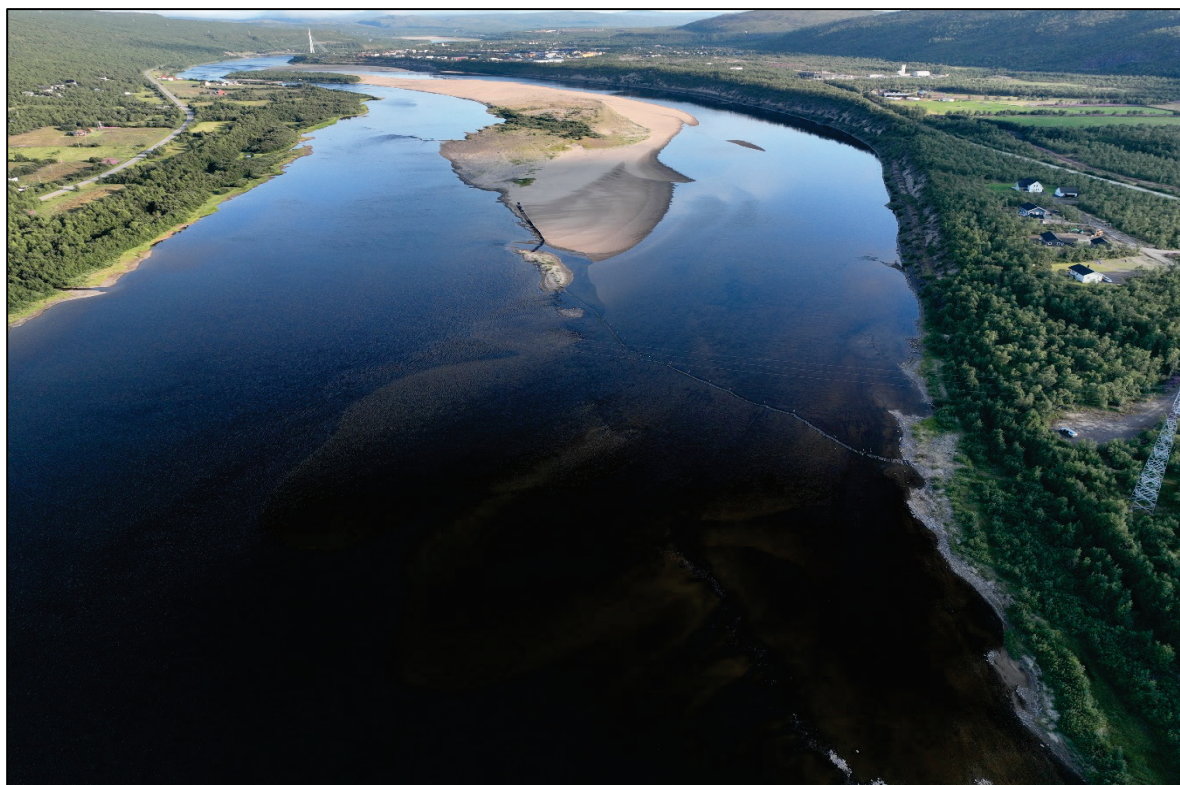
Figure 6. Drone photo taken from the north end on the Seidaholmen looking south towards Tana bru on July 28th. In the downstream part of the western channel (to the right) the black flexible fence is visible spanning from the sand banks on the island to the stone banks on western shore. Photo: Joachim Henriksen, Tana.

In the western channel a 500-600 meter long flexible fence, like the one in the eastern channel but with approx. 60 mm. spacing between the plastic pipes, was installed, spanning across the whole channel (**Figure 6**). The area at the western channel fence was characterized by sandy bottom and relatively shallow and even depths. An opening intended as a downstream migration solution, like the one in the flexible fence in the eastern channel, was created close to the western shoreline.

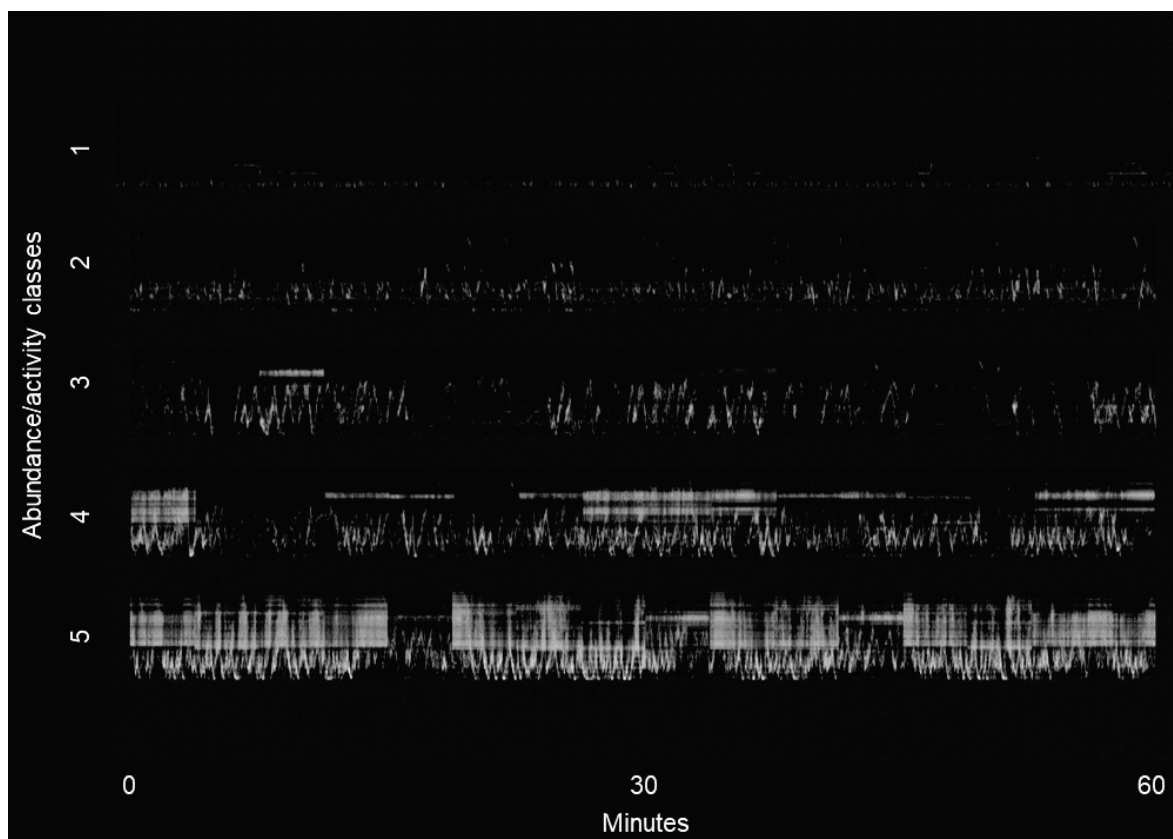
Figure 8. Five, one-hour long echograms illustrating what classifies as the five abundance/activity classes (y-axis) used for making the abundance/activity index. The top echogram represents “very little” activity (abundance/activity class 1), and the bottom echogram represents “a lot” of activity (abundance/activity class 5). In each echogram the y-axis represents the distance from the sonar and the x-axis is time. The white streaks seen in the echograms are primarily fish, meaning more white streaks in the echogram = a higher abundance/activity of fish in the area.

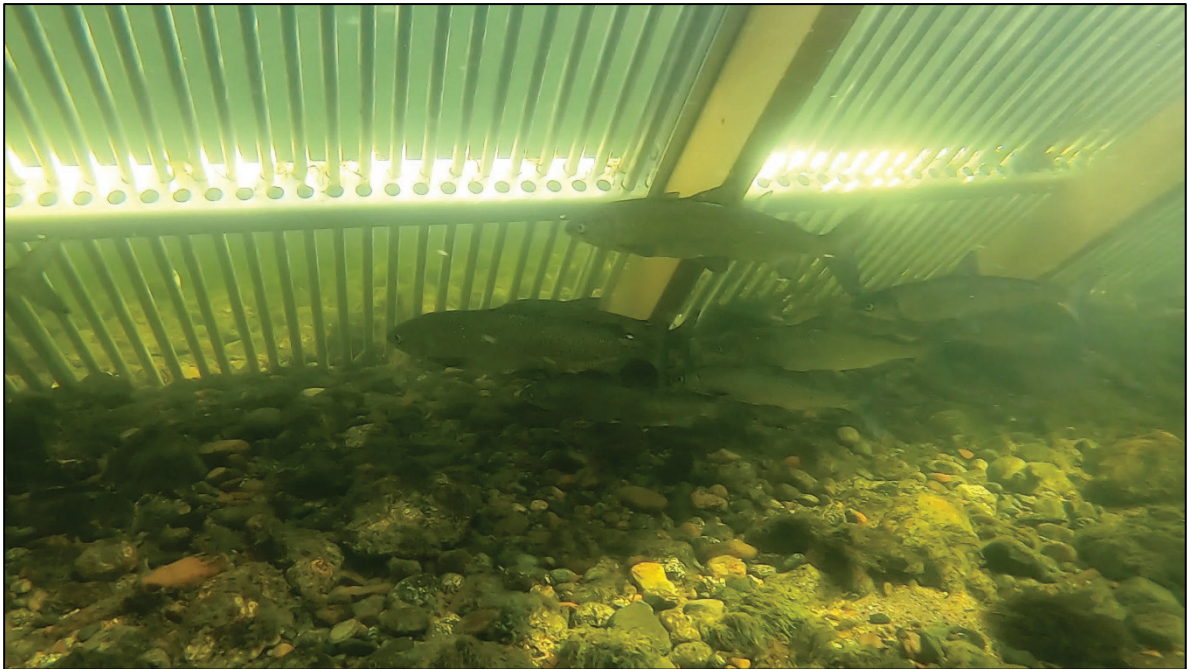
Figure 21. A school of 12-15 whitefish observed under the trap on July 11th, 2023. Photo: S. Domaas, NINA.

Snorkelling along the fence revealed individuals of both pink salmon and Atlantic salmon seeking migration routes (openings) along the fence (**Figure 20**) as well as standing still below the fence. The snorkelling also revealed the presence of other species than just Atlantic salmon and pink salmon. During snorkelling, grayling, European flounder and brown trout were observed, and maybe the most interesting observation were pure schools of whitefish close under the fence (**Figure 21**).

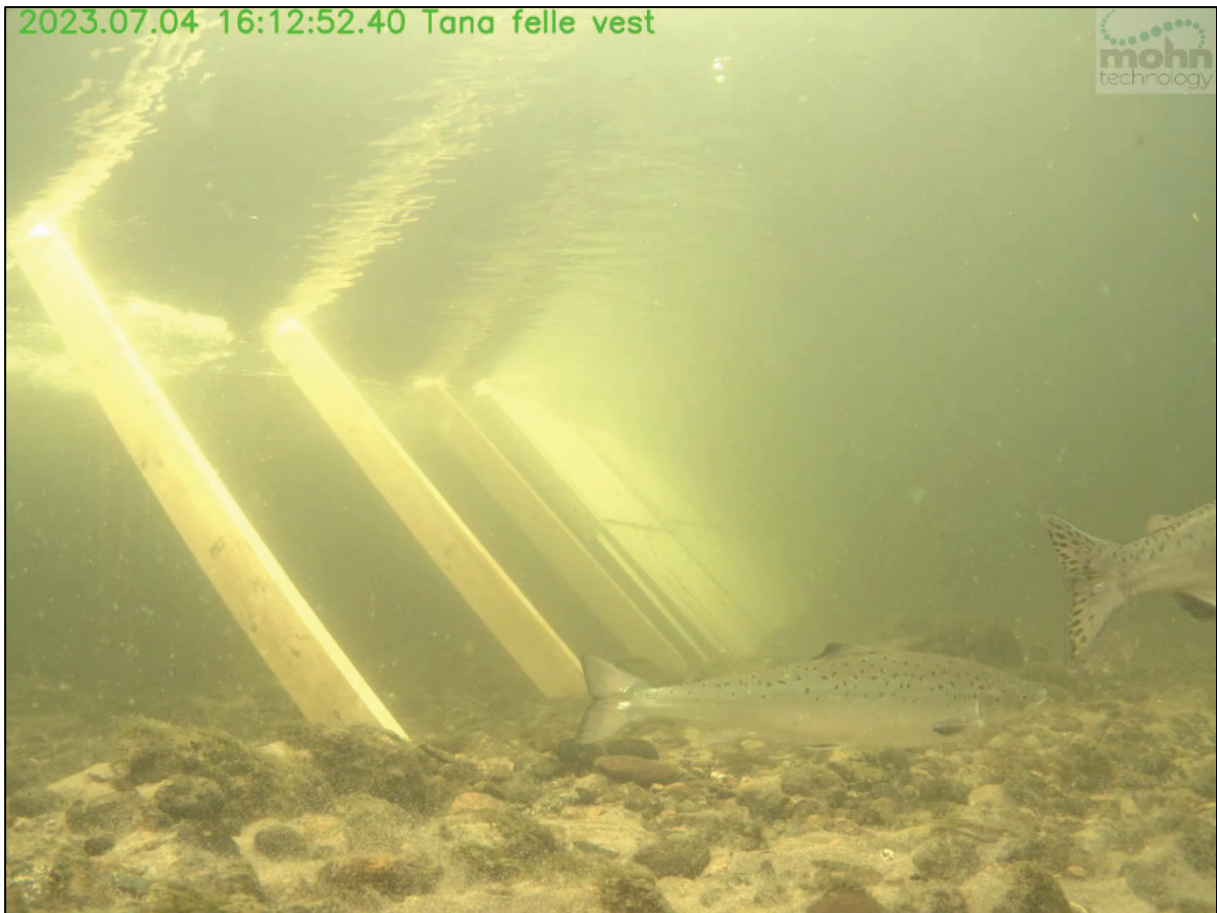
Figure 23. The bypass opening made by removing three sections of the fence for the bypass of Atlantic salmon and other native species on the 3rd and 4th of July 2023. On the picture we see the tail of a pink salmon and an Atlantic salmon following closely behind. Photo: Mohn Technology.

During the period from 19:50 on the 3rd to 18:00 on the 4th of July, and the period from 17:45 on the 7th of July to 17:00 on the 8th of July, three sections of the trap were completely removed as seen in **Figure 23**.

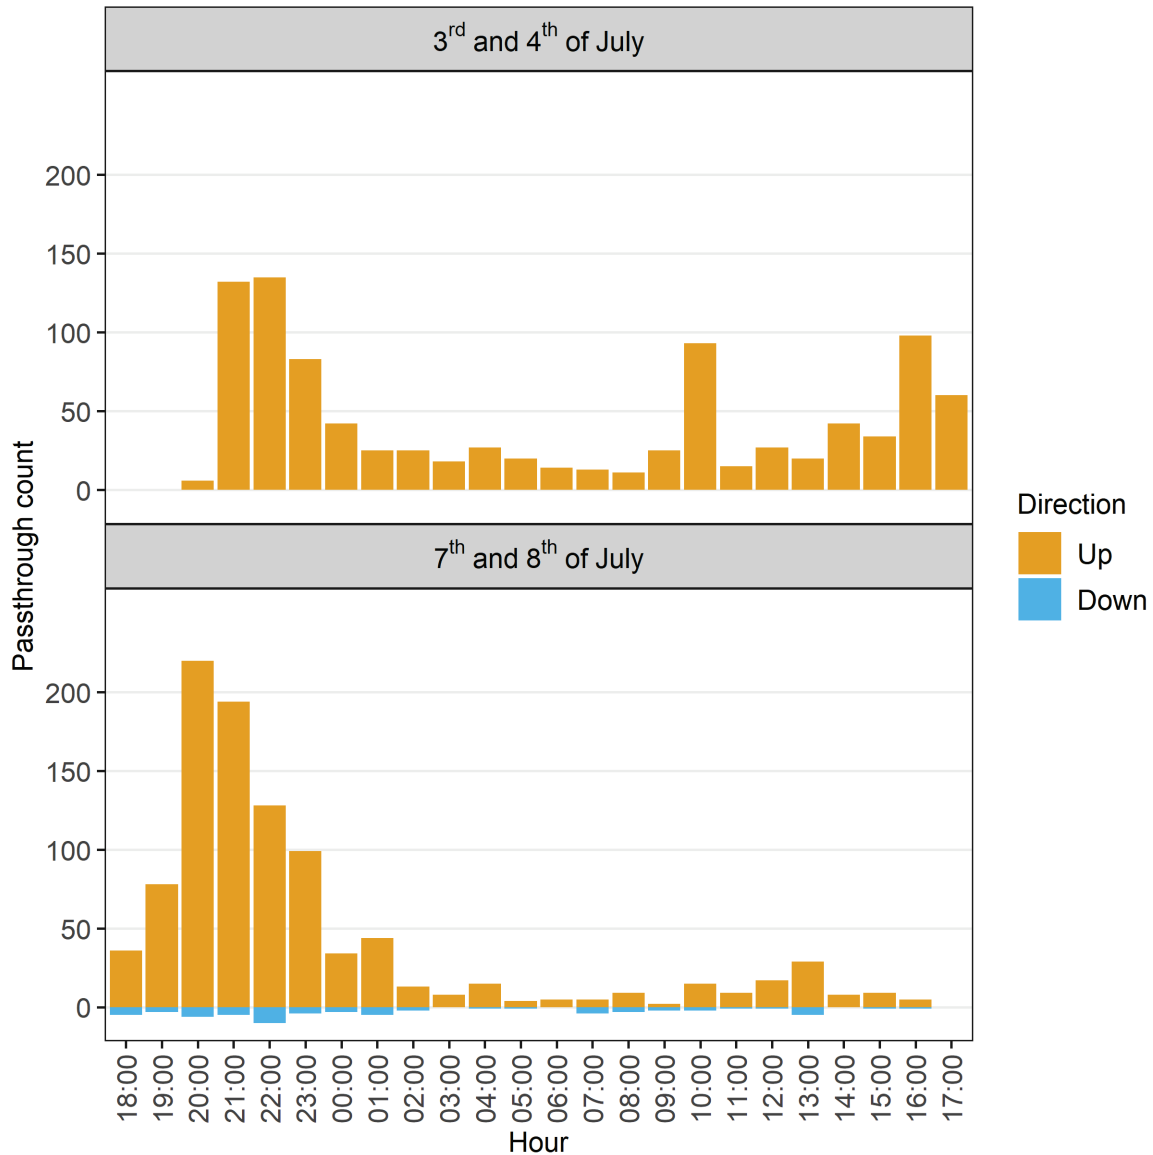
Figure 24. Overview of hourly counts through the bypass opening on the 3rd-4th and 7th-8th of July 2023. X-axis: hour of the day (be aware of the date change at 00:00 and its placement on the axis). Y-axis: counts of up (above 0) and down (below 0) migrating fish. In the first period only upstream migrating fish were included in the count. The highest number of down migrating fish counted in a single hour in the second period was ten.

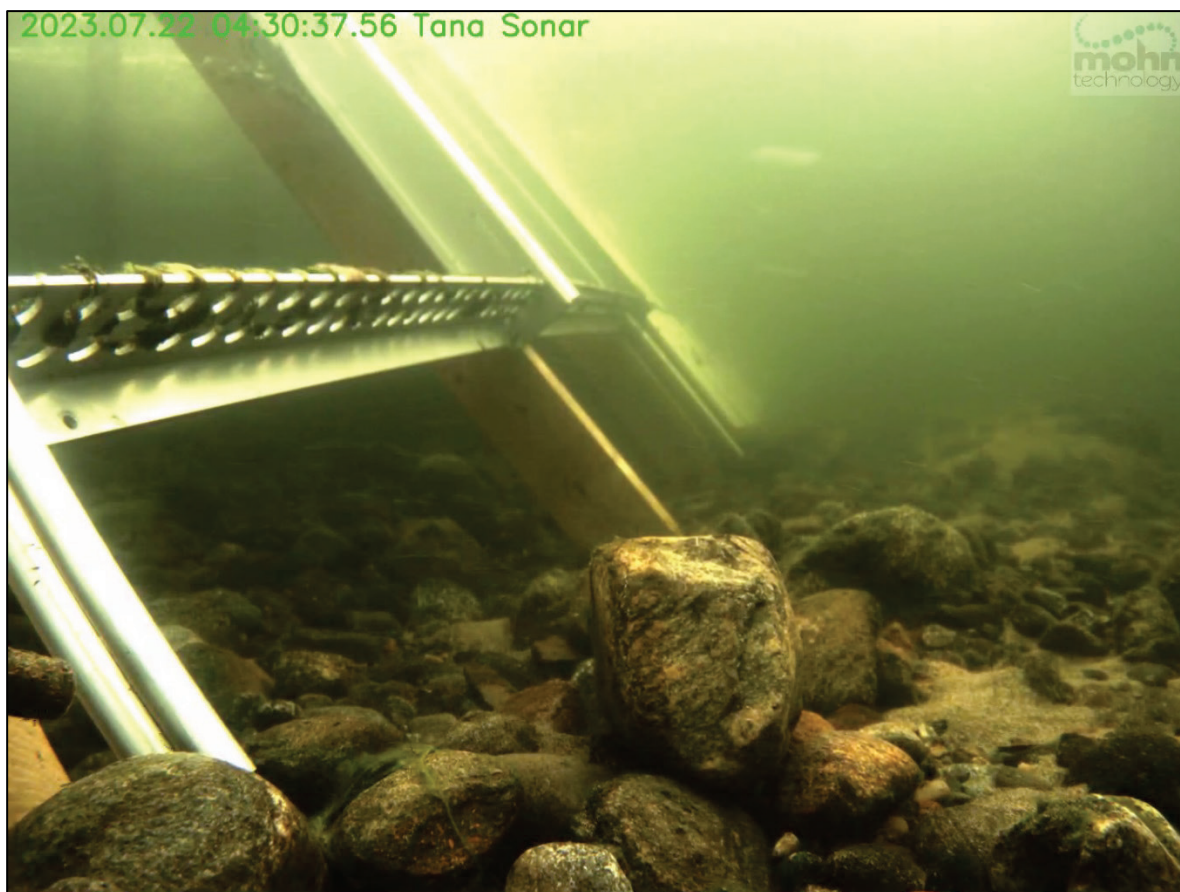
Figure 27. The bypass opening created by removing the aluminium poles from two aluminium frames for the bypass of Atlantic salmon and other native species on July 21st and 22nd, 2023. Photo: Mohn Technology.

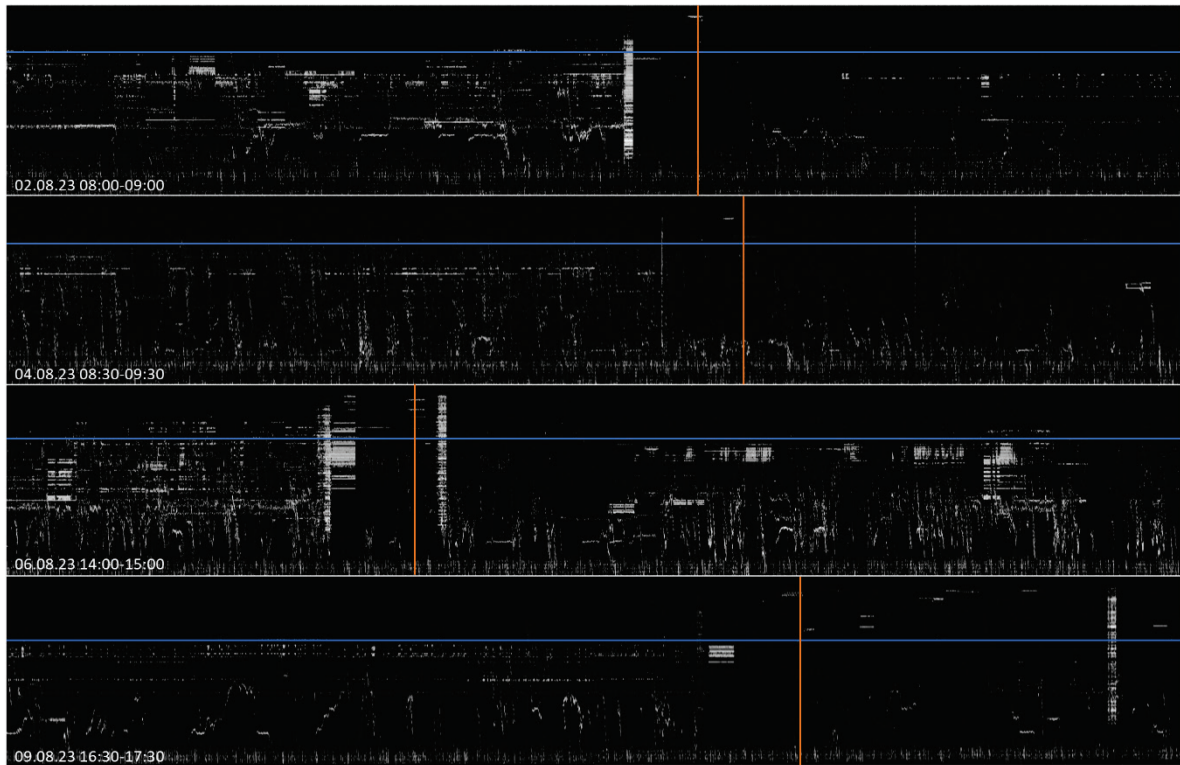
Figure 29. Sonar (ARIS) echograms from the area below the bypass opening in the period immediately before and after the bypass opening was opened on the 2nd, 4th, 6th and 9th of August (lower left corner of echograms). In each echogram the y-axis represents the distance from the sonar and the x-axis represents time (each echogram is 60 minutes long). Blue horizontal lines indicate the 10-meter distance from the ARIS, which is the distance from the ARIS to the bypass opening. The orange vertical lines represent the approximate time the opening was completely open (all aluminium poles removed from the two sections). The white streaks seen in the echograms are primarily fish, meaning more white streaks in the echogram = a higher abundance/activity of fish in the area. The abundance or activity of fish in the area decreased in the period immediately after personnel from the trap operation team came to open the bypass opening.

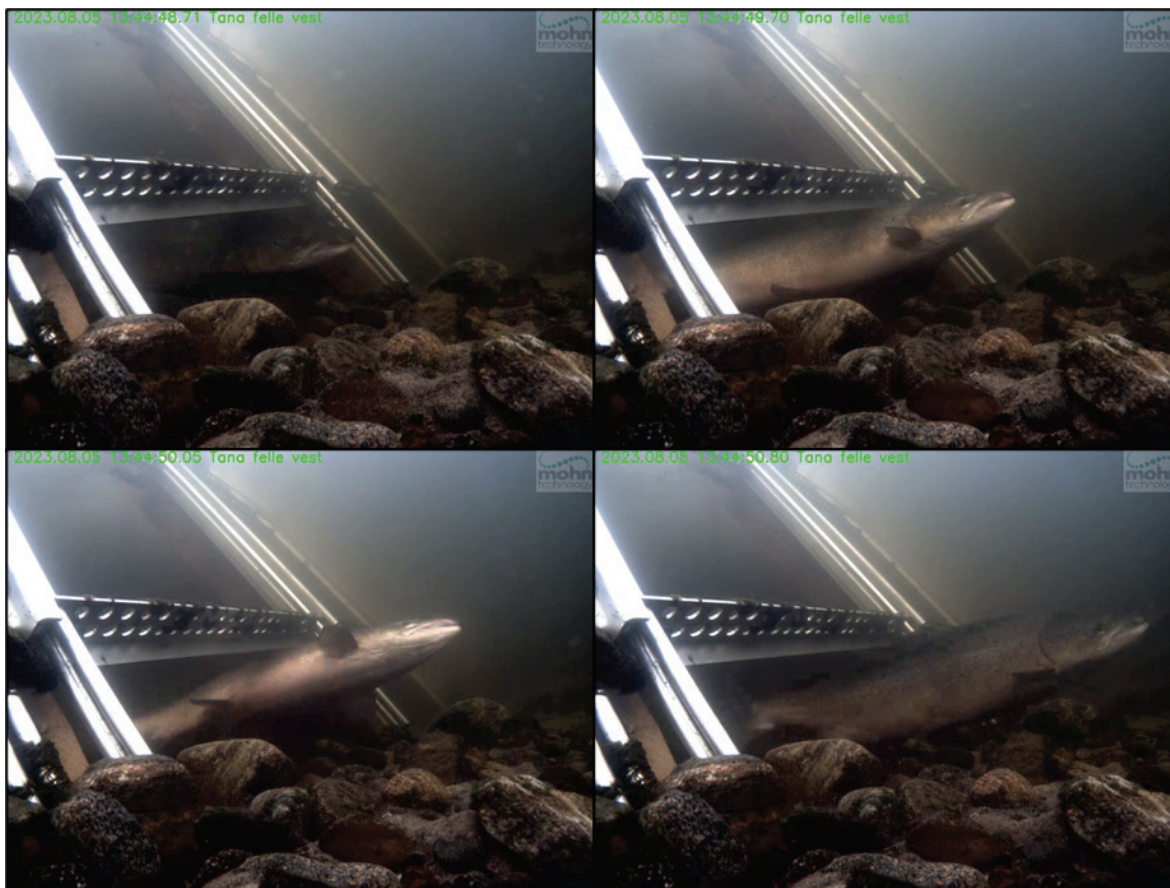
Figure 30. Sequential series of pictures (from top left to bottom right) showing a large salmon, measured to 98 cm on the sonar, making its way through the bypass opening on August 5th, 2023. As we can see, the aluminium frame did pose as a challenge, requiring some agile swimming from the larger salmon to pass under it.

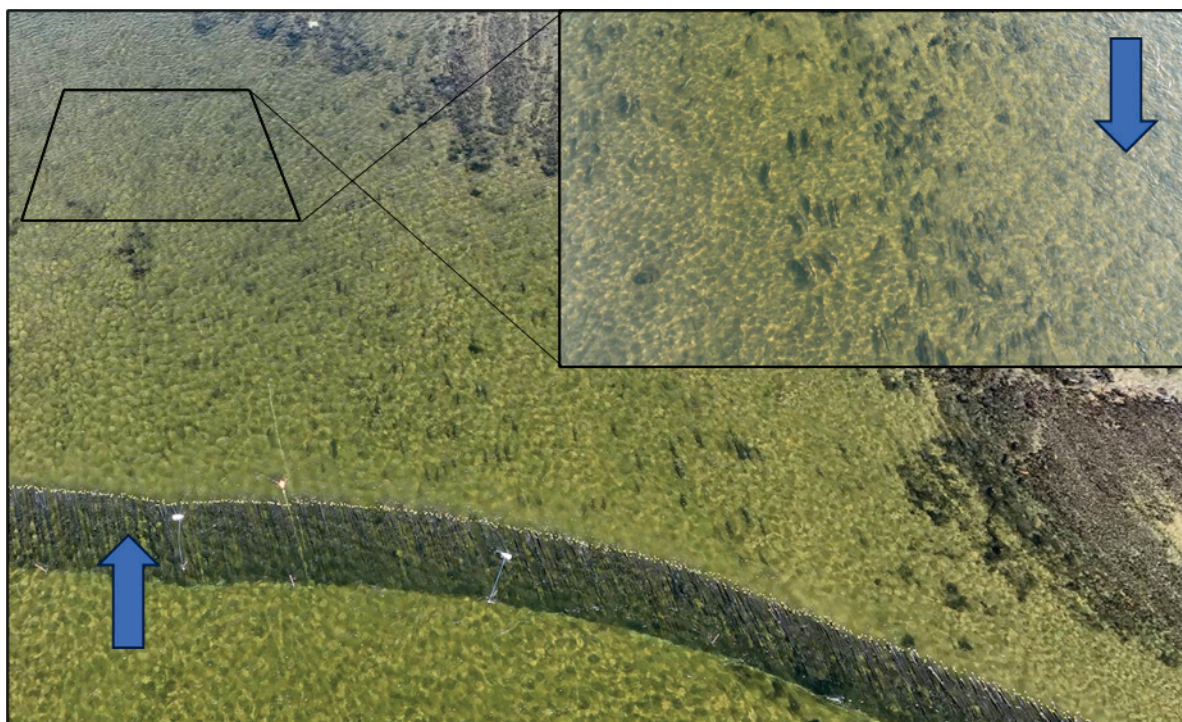
Figure 31. Drone footage showing hundreds of fish gathered downstream to the flexible fence in the western river channel at the northern end of the Seidaholmen, on July 9th, 2023. Blue arrows indicate flow direction in the pictures. The fish are visible as darker lines against the bright sand. In the big photo we can roughly 300 fish, many of these relatively close to the fence, but as indicated by the zoomed in picture showing the (approximate) area in top left corner of the big photo, there were many fish concentrated into small areas further downstream as well. Another large concentration of more than 100 fish was also found further west in this video. The counting of fish in parts of the picture area was made in more zoomed-in videos. Photos: Joachim Henriksen, Tana.

Large amounts of fish in all size classes were observed downstream to the western fence on multiple occasions. The first drone footage was made on June 30th, and is not comprehensive for the area. At least 70-100 fish, many of them too large to be pink salmon, can be discerned in the videos. Next drone footage was made on July 4rd, this time also covering only parts of the river channel width. Still, more than 125 fish, many of them large, were seen downstream to the fence. Drone footage from July 7th cover areas very close to the fence, and reveals more than 150 fish. On July 9th, 400-500 fish could be seen on a larger overview of the flexible fence and the downstream area (**Figure 31**). For the next days no overview of the area were available, but 200-300 fish could be seen close to the fence on July 12th. By July 17th, numbers close to the downstream side of the fence were 50-100, and by July 20th numbers close to the fence were apparently 30-50 fish, but higher water level and poorer water transparency made counting more difficult. Similar numbers were observed on July 27th and 28th, which were the last days with drone footage available.

Although the area coverage was only partial for most of these days, the numbers reveals a pattern of increasing fish numbers from Jun 30th to July 9th downstream to the flexible fence in the western river channel, whereafter the fish numbers in the area decreased. Fish numbers on the downstream side were always many times as high as numbers on the upstream side, indicating

a hold-back effect. As observed for the eastern river channel, fish were observed holding position both close to, and far downstream to the flexible fence. The observed holding behaviour was every now and then broken up by highly active swimming, potentially as a result of aggressive behaviour. Some fish with wounds were observed, but we cannot know if these were acquired before the fish arrived the area. Moreover, both fish schools and single fish were observed searching along the fence, apparently looking for bypass opportunities. Although this rarely led to fish intrusion through the fence, it sometimes did (**Figure 32**). The share of large fish (thus not pink salmon) was higher in the beginning and end of the period with drone footage than at the peak of fish abundance around July 9th-12th, potentially indicating that pink salmon left the area faster than Atlantic salmon. On July 20th and July 23th 19 fish were observed on the Seavision cameras swimming through the flexible fence each day. Some additional fish were observed coming into the video frame from a direction suggesting that they also swam through the fence, although the fence itself was not visible at this angle. If each of the camera covered approx. 2-3 m, the four camera together covered around 5% of the river channel width of about 200 m at the flexible fence. Scaling fish numbers observed traversing the fence up to full river width reveals a daily fence traversal by fish on the scale of 400 fish for each of these two dates, but we don't know how representative the observe numbers were for the other parts of the flexible fence.

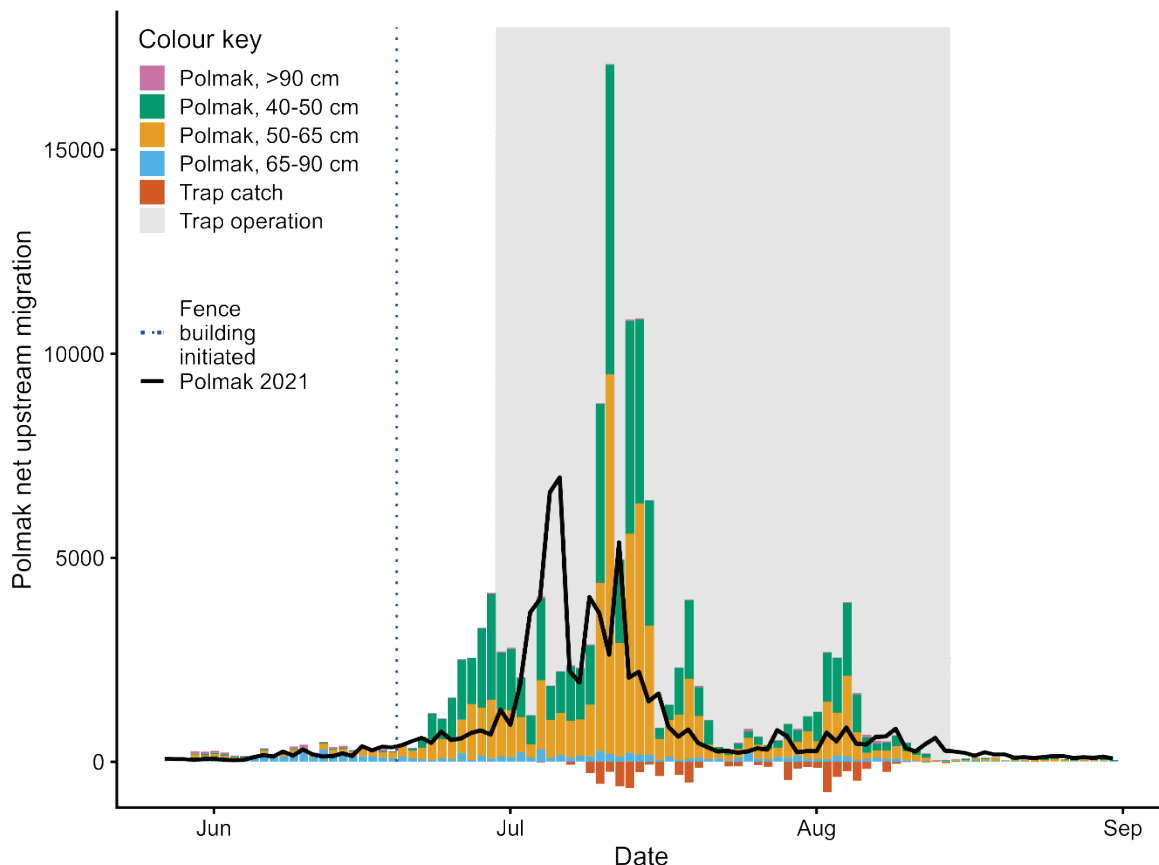
Figure 34. Daily counts (net upstream) of fish in four size categories based on the Polmak sonar monitoring 30.5.-31.8.2023, combined with daily trap catches at Seidaholmen as negative counts. For comparison, daily counts at the Polmak sonar from 2021 (all size groups >45 cm) is shown with a black line. The start of the fence building at Seidaholmen is indicated by the blue vertical dotted line, and the grey-shaded area indicates the period of trap operation.

The run estimate of ≥ 40 cm fish was 142 000 individuals based on sonar counts (**Figure 34**), before school density correction (see further below). The majority (92%) of fish belonged to size groups 40-50 cm and 50-65 cm. The first peak in up-migrating fish was observed in late-June, the highest peak during the period from July 10th to July 15th, and the last peak in early August (**Figure 34**).

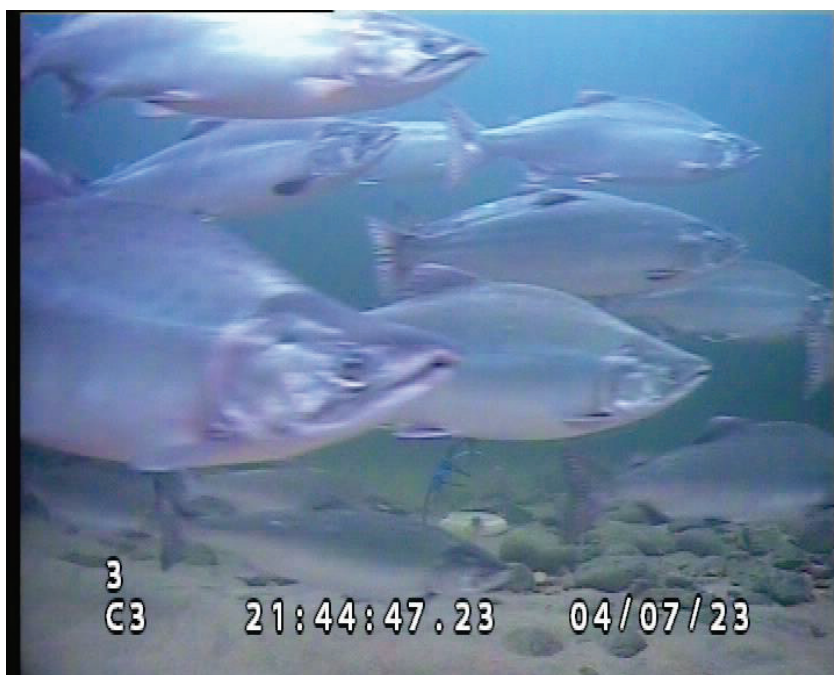
Figure 35. Still image from an underwater camera installed to Polmak sonar counting window indicating pink salmon schooling behaviour. The schools were large and dense compared to schools of Atlantic salmon. Photo: Panu Orell.

In the case of the pink salmon the video data revealed a significant underestimation of pink salmon numbers from sonar data. This underestimation was caused by pink salmon swimming in large and dense schools that were not possible to count precisely from the sonar images (**Figure 35**). When using school size correction factor derived from the underwater video data combined with synchronous sonar data analyses, the pink salmon run estimate past Polmak was in the order of 170 000 individuals in 2023.

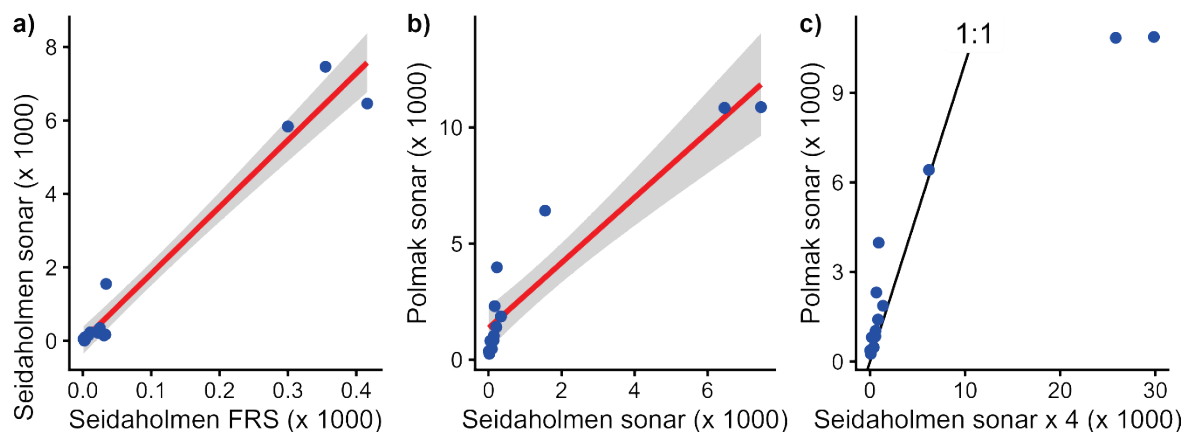
Figure 36. Comparison of FRS to DIDSON sonar in the Seidaholmen western channel (a) and DIDSON sonar in the Seidaholmen western channel with Polmak sonar (b and c) for the period 12.07-25.07.2023. a) Comparison between daily net upstream migration estimates at Seidaholmen as assessed by the FRS-camera and by the DIDSON sonar. Blue dots represent daily estimates, numbers in thousands. Red line indicates linear regression line with 95 % confidence interval indicated by grey shading. b) Comparison between daily net upstream counts as assessed by the DIDSON sonar in the Seidaholmen western channel with net upstream migration assessed by sonar at Polmak. Blue dots represent daily estimates, numbers in thousands. Red line indicates linear regression line with 95 % confidence interval indicated by grey shading. c) Same figure as in b, but with Seidaholmen net daily upstream migration estimates obtained by daily counts multiplied by 4 to scale up from 20 m analysis range to 80 m river channel width. The black line indicates line of unity, i.e., the numbers observed at Polmak would be the same as the numbers observed at Seidaholmen, western channel.

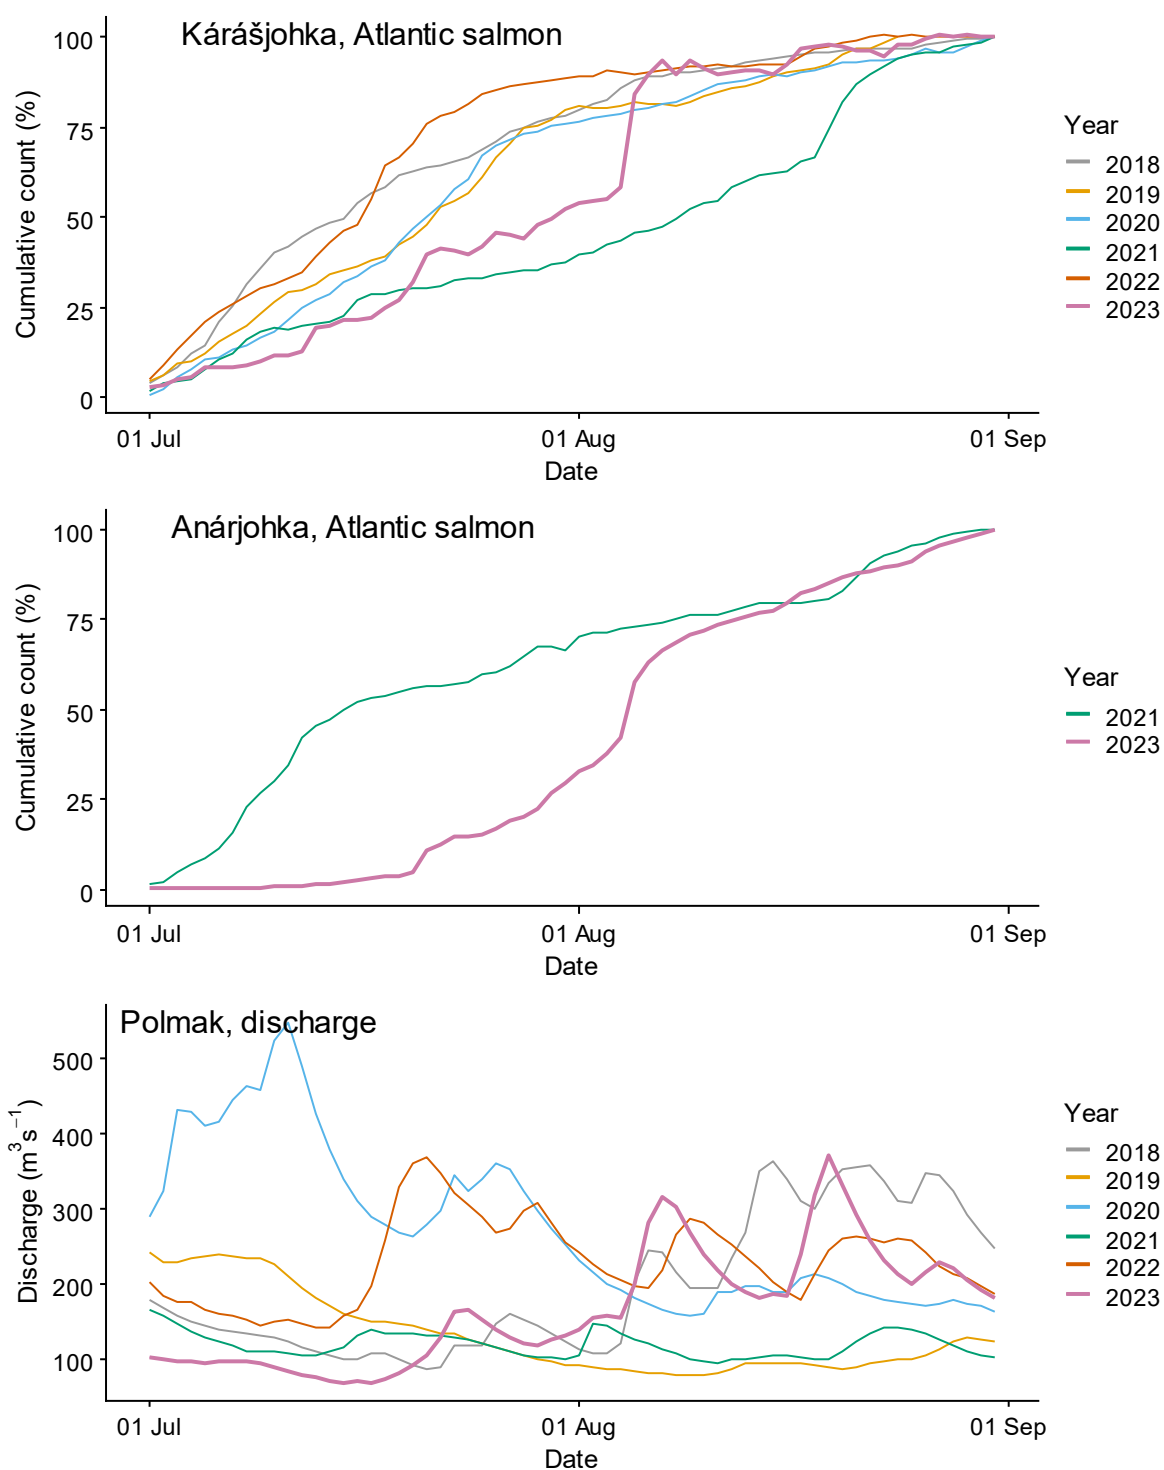
Figure 39. Cumulative counts of Atlantic salmon ≥ 65 cm length in Kárášjohka, years 2018-2023 (upper), Anárjohka years 2021 and 2023 (middle), compared to daily mean discharge at Polmak (lower) in the period from 1. July to 1. September.
