1628 Restoration potential of old dams in Norway

A pilot study of occurrence, characteristics and restoration potential in watercourses with anadromous and resident fish stocks

Eloranta, A., Thomassen, G., Bergan, M.A., Andersen, O. & Gregersen, F. 2019. Restoration potential of old dams in Norway. A pilot study of occurrence, characteristics and restoration potential in watercourses with anadromous and resident fish stocks. NINA Report 1628. Norwegian Institute for Nature Research.

Trondheim, February 2019

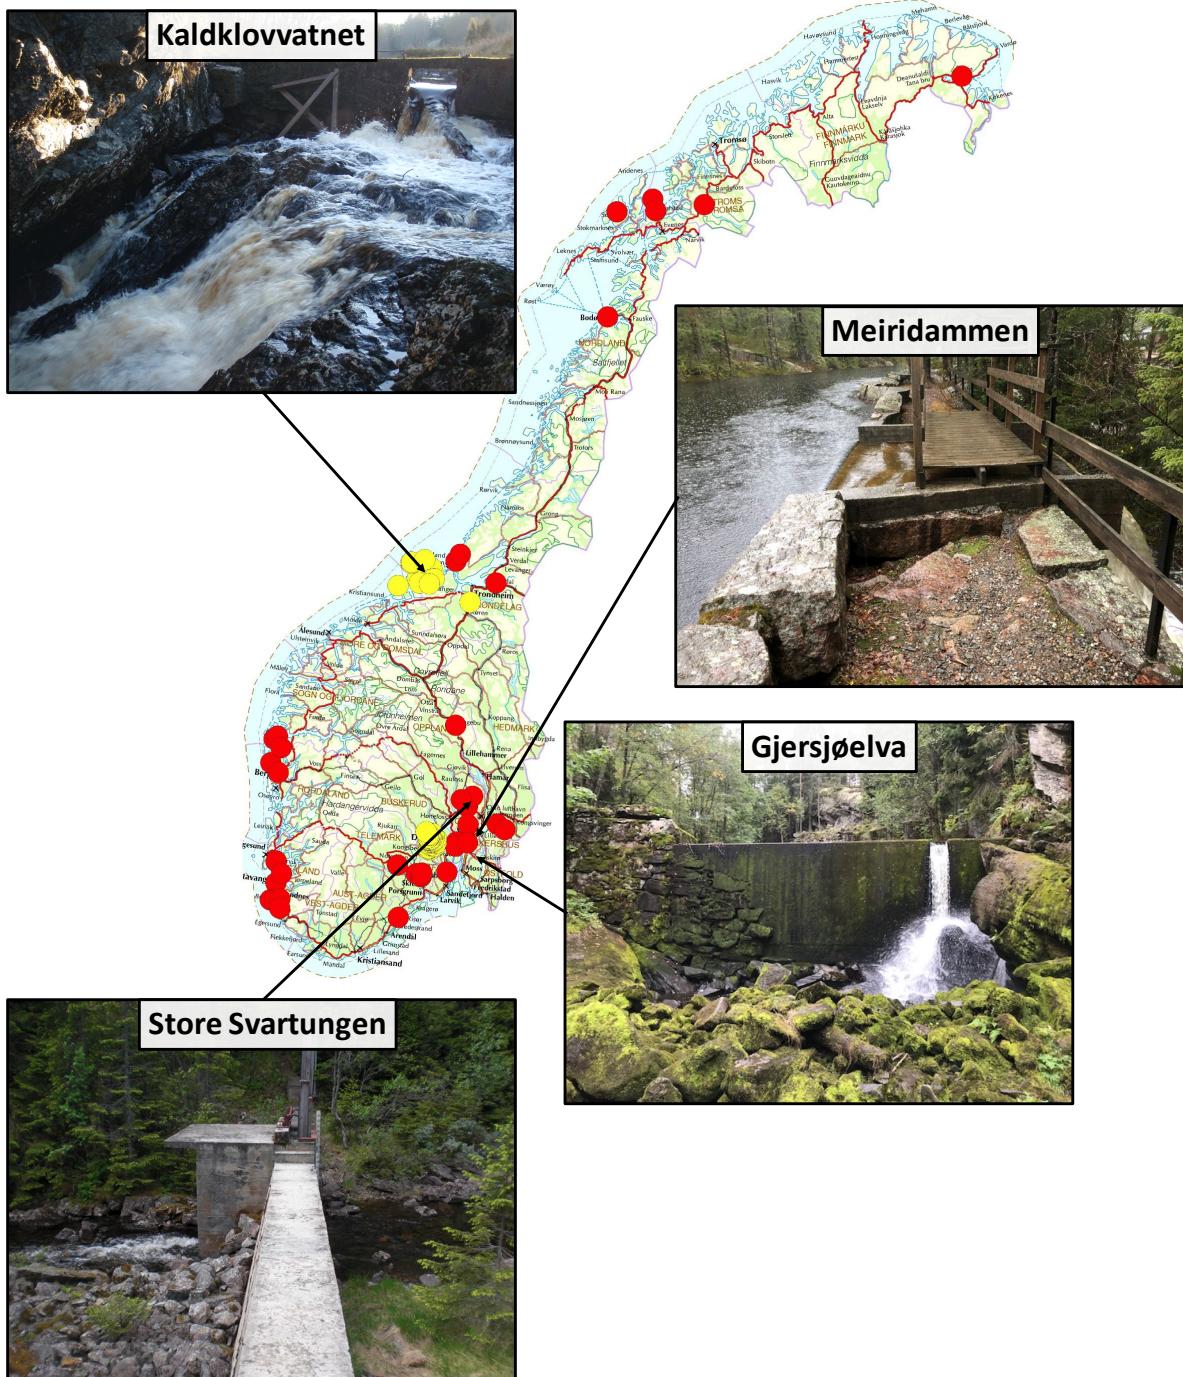
Figure 3. Location and some photos of dams reported via the electronic questionnaire (red dots) and included in the field surveys (yellow dots). Photos: © Morten Andre Bergan (Kaldklovvatnet), Roy Winge (Meiridammen), Sander Engeland (Gjersjøelva) and Erik Olstad (Store Svertungen).

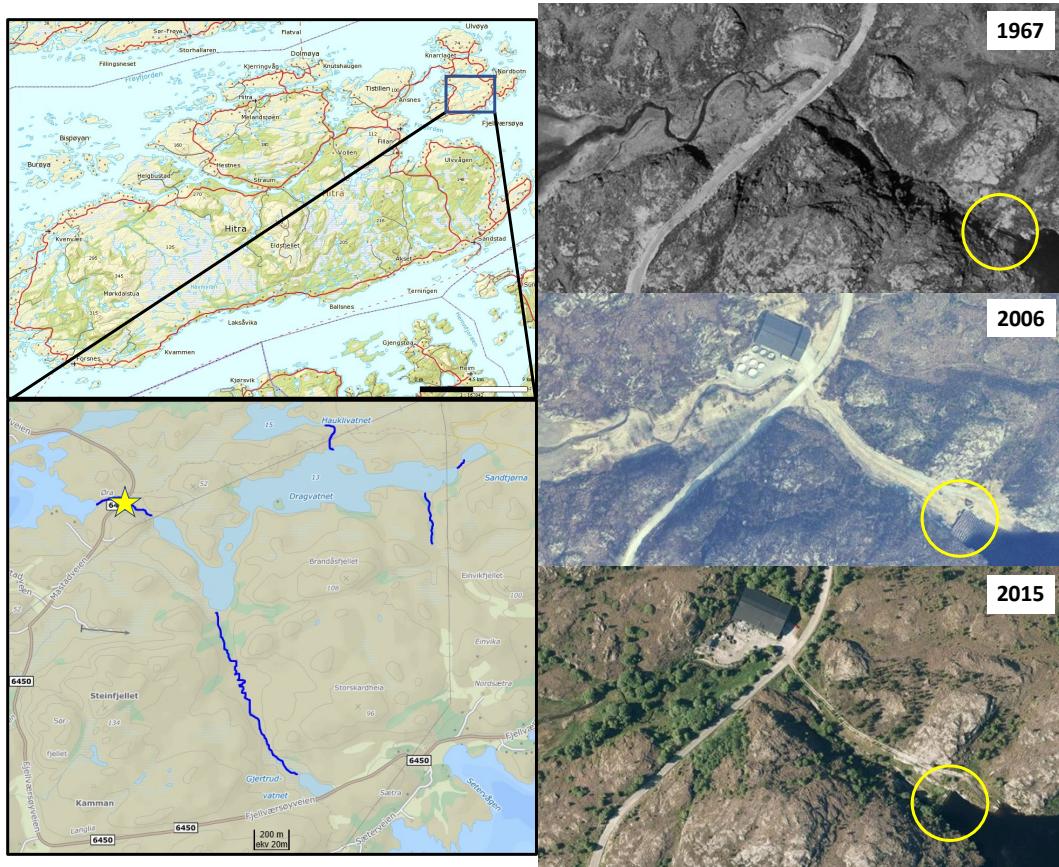
Dragvatnet (14 m a.s.l.) is the largest lake at Fjellværsøya island connected with a bridge to the larger Hitra island (**Figure 4 and 8**). Besides the lake outlet, Dragvatnet has four inlet streams including the streams from Sandtjørna (14 m a.s.l.), Hauklivatnet (15 m a.s.l.) and Gjertrudvatnet (37 m a.s.l.). All these small streams were likely suitable spawning and nursing habitats for resident trout, sea trout and/or salmon before a concrete dam was built at the Dragvatnet outlet (**Figure 8 and 9**). It is unknown exactly when the dam was built for the fish hatchery, which has been closed down since many years. It is not known how the fish populations were affected by the damming, but based on local knowledge and historical aerial photos, the streams connected to Dragvatnet have had viable sea trout stocks, probably because an old stone dam visible in photos from 1967 did not create a migratory barrier for fish, unlike the newer 1 m high concrete dam. This dam still exists although the fish hatchery is closed (**Figure 8 and 9**).

Figure 9. The location of Dragvatnet and its outlet dam (yellow star) at Fjellværsøya island connected to Hitra island. Blue lines indicate inlet and outlet streams around Dragvatnet. These streams were accessible for migratory fish before a small stone dam (see yellow circle in aerial photo from 1967) was replaced by a 1 m high concrete dam built for the fish hatchery (see photos from 2006). Today, the hatchery is closed but the concrete dam remains (see photo from 2015). Map and aerial photos obtained from <https://kart.finn.no>.

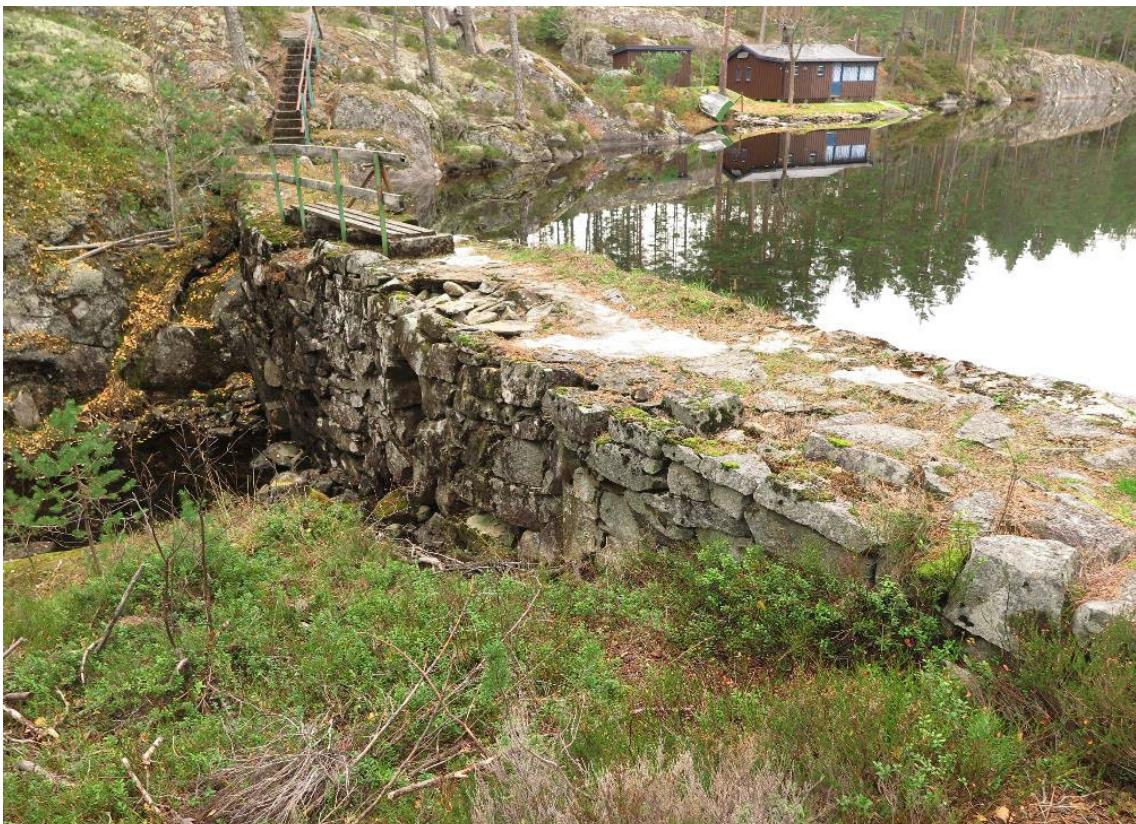
Figur 1: Dam ved Mortenstjern i Bingselvavassdraget.

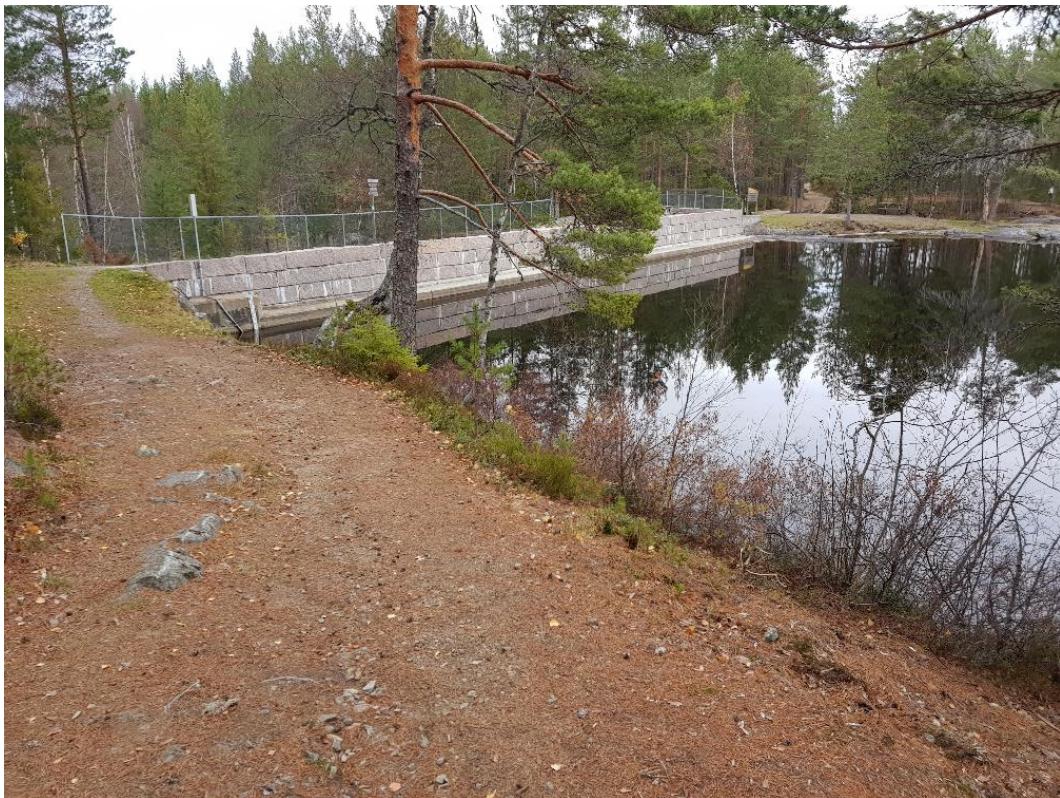
Figur 4: Himsjødammen i Hoenvassdraget.

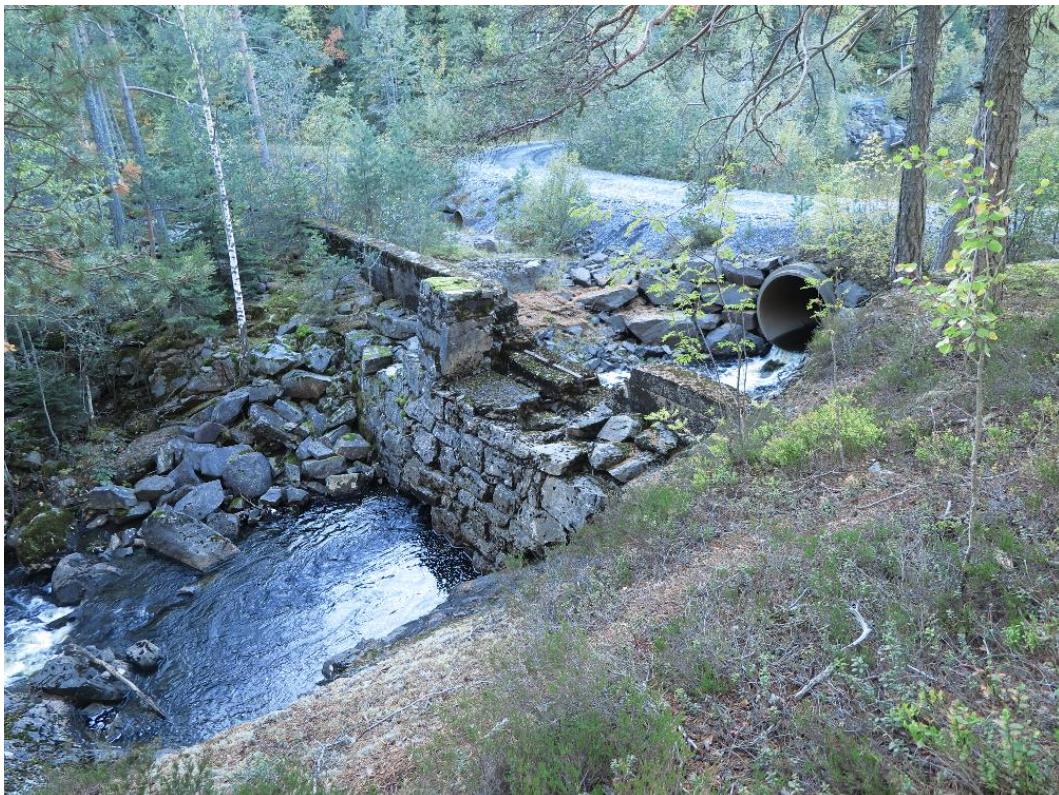
Figur 6: Jørandruddammen i Darbuelva/Fiskumelva.

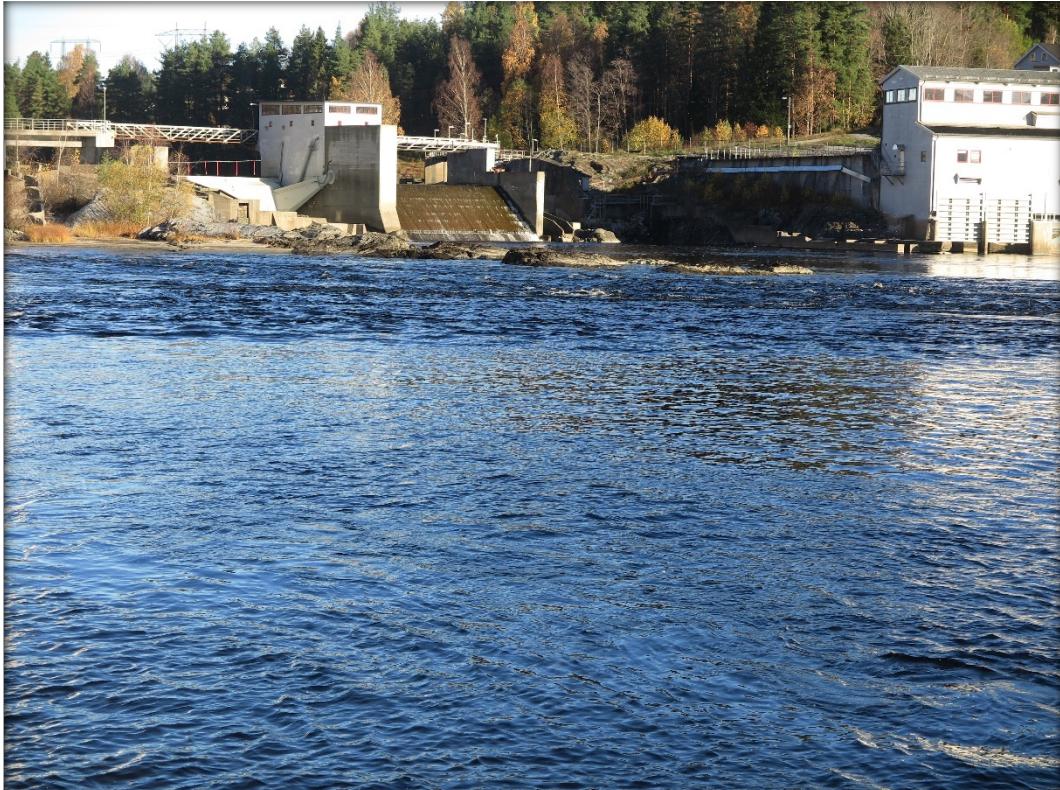
En av installasjonene som er med i materialet ligger i Drammenselva. Dette gjelder Hellefossen (Figur 7) som er inkludert her siden fisk som kommer nedstrøms fra og skal opp til Bingselva må forbi denne via fisketrappa som er installert der. Her finnes et av landets store elvekraftverk.

Figur 7 Dammen på Hellefossen, Drammenselva.

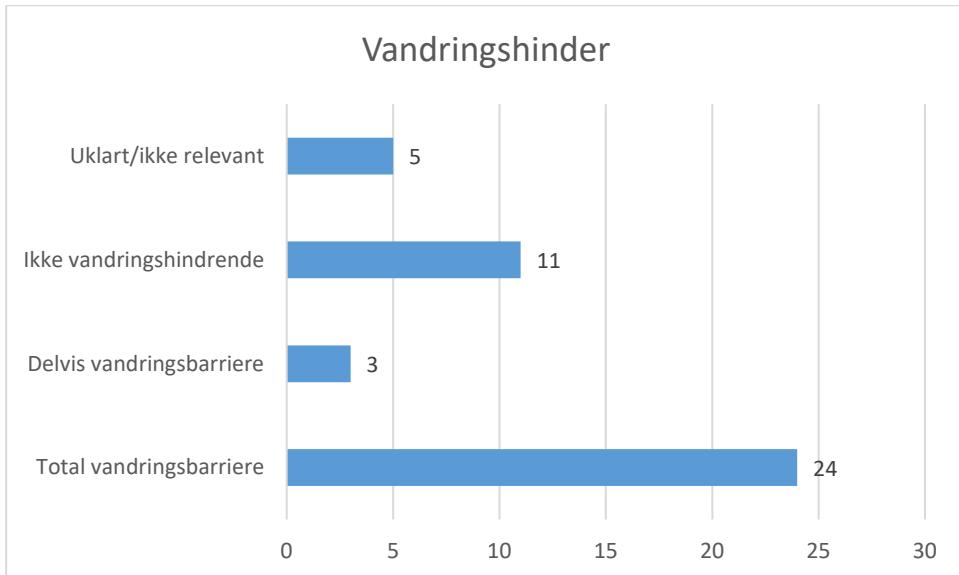
For dammene i dette systemet vurderer vi at ca 56 % av dammene utgjør totale vandringshindre for laksefisk. 7 % vurderes som delvis vandringshindrende, mens ca 26 % anses for å ikke være vandringshindrende (Figur 9). For de resterende dammene vurderes fiskevandringsproblematikk som ikke relevant av ulike årsaker. Den vanligste årsaken til dette er at det er andre naturlige vandringshindre som medfører minst like stor vandringsbarriere som den aktuelle installasjonen.

Figur 9: Vurdering av de vurderte installasjonenes effekt som vandringsbarrierer.
